# Pre Purchase Building & Pest Report

**Besafe Group Pty Ltd**

**The Scope of the Inspection:** This report Complies with Australian Standards AS 4349.1-2007. Inspection of Buildings Part 1: Pre- Purchase Inspections-Residential Buildings- Appendix "C" and with AS 4349.3-2010 (Visual Timber Pest Inspection Report)

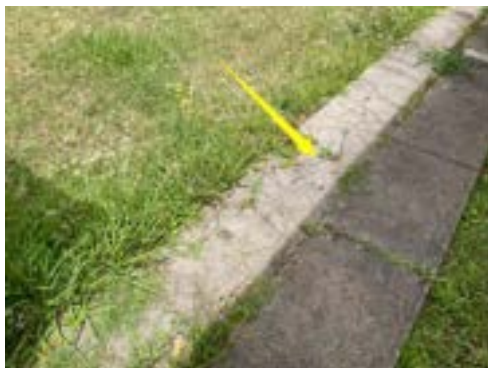
### **Pathways Condition**

The concrete path is in poor condition replacement recommended. Contact a qualified concreter for repairs.

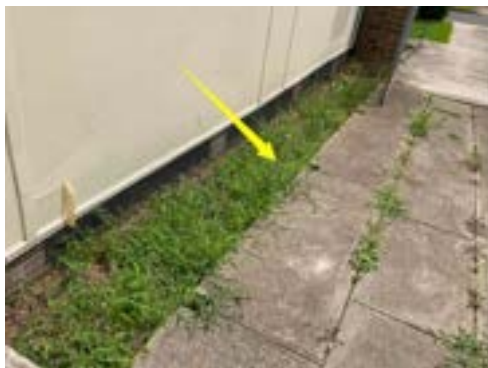
### **Drainage Findings**

The ground levels along the perimeter walls at the side of the home did not appear to fall away from the property walls sufficiently due to the natural landscape and contour. This will need to be assessed during a period of rainfall and if surface water appears to be entering the sub floor if applicable or ponding against the perimeter walls, engage a plumber or landscaper to assess and rectify as required. All drains should be regularly checked by a plumber and kept clean of debris to allow surface water to be carried away from the dwelling.

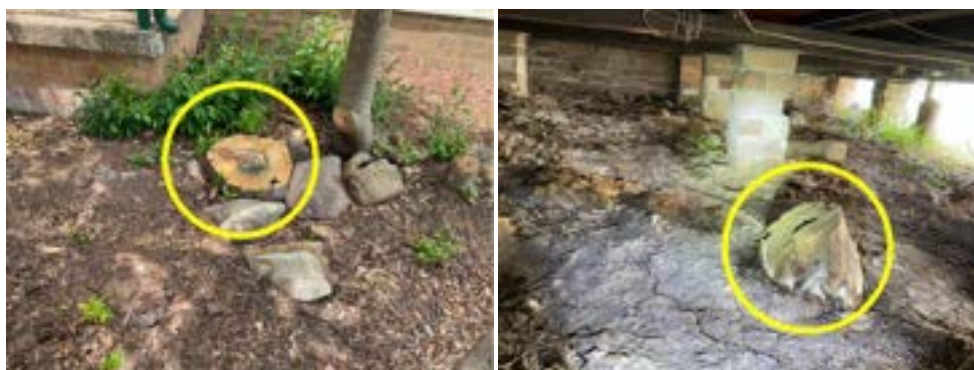
### Tree Findings

Old tree stumps are located throughout the site. These need to be removed as they are conducive conditions for termite infestation.

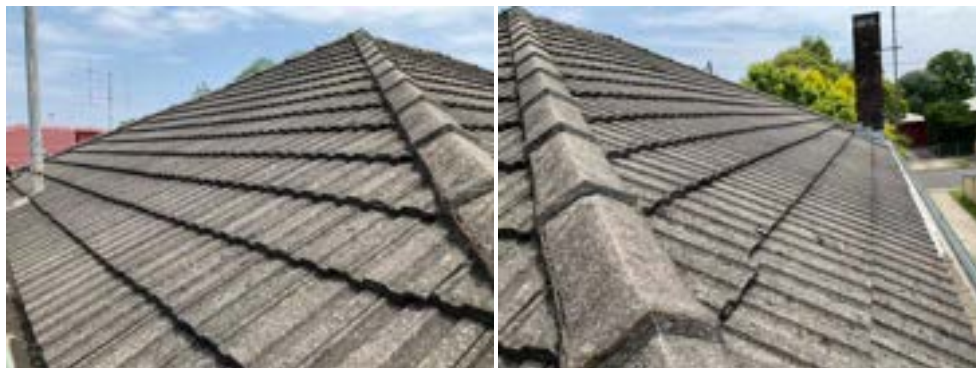
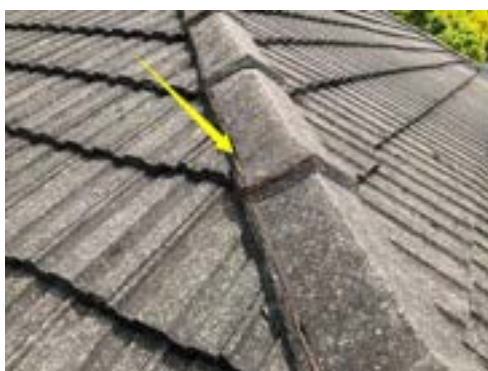
## Roof Clad Condition

Mortar cracks visible. We recommend having these repaired by a qualified roofer as they may contribute to water ingress.

Deterioration & ageing evident. I recommend you contact a roof restorer to clean, seal, and repoint the mortar.

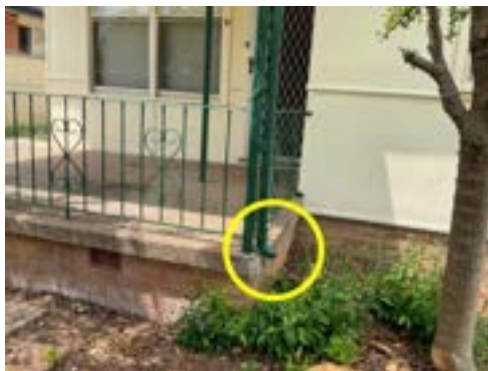
### Downpipe Findings

Downpipe/s not connected to storm water discharge - Downpipes not connected to storm water have the potential to cause differential settlement to the footings, cause rising damp and is also conducive to termite infestation. A qualified roof plumber should be engaged for advice and recommendations.

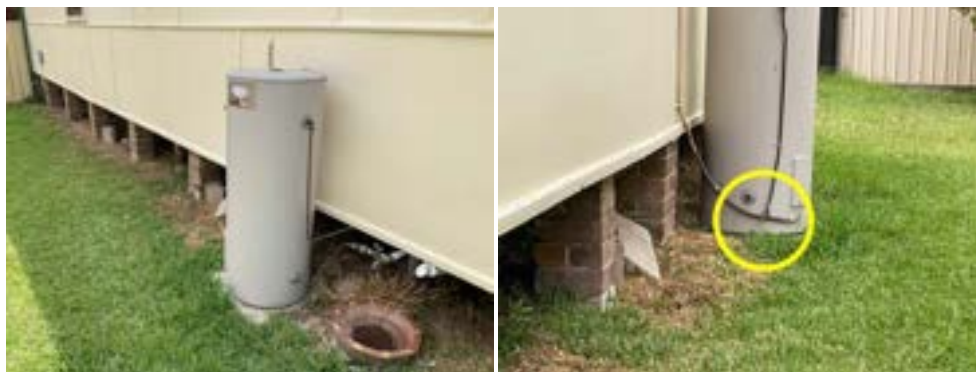
The hot water overflow requires diverting to a drain or further from the dwellings wall or footings. Excess water ponding alongside walls and into perimeter footings has the potential to cause rising damp, differential settlement and wall cracks over time. It is also conducive to termite infestation. Recommendations: Engage a plumber to rectify.

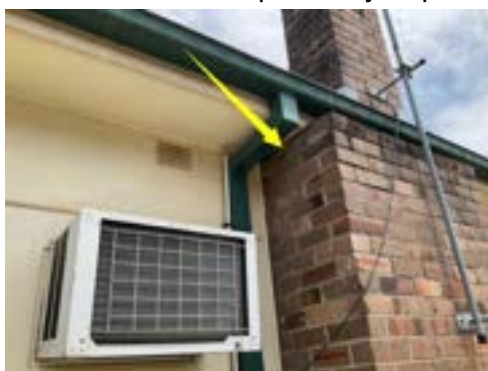
Minor brick damage observed to the brickwork. Have repaired by a qualified brick layer.

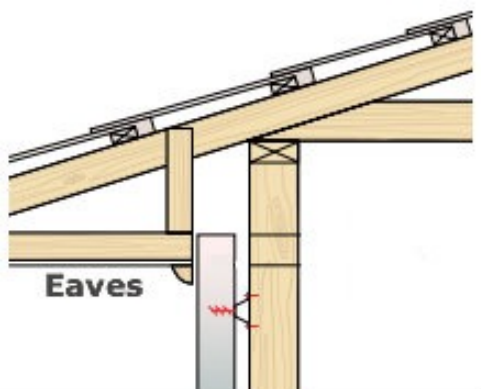
#### Eave Condition

Minor eave deterioration & ageing evident. Recommendations: Maintenance works, general upkeep should be carried out.

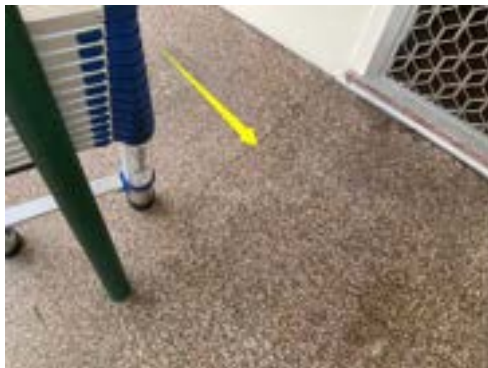
### Base or Flooring Condition

Typical cracks evident - Recommendations: Engage a qualified concreter or tiling contractor to repair. Please note: Whilst these cracks appeared to be minor at the time of inspection, we strongly recommend you monitor these cracks and if worsening occurs contact a brick layer/tiler for advice.

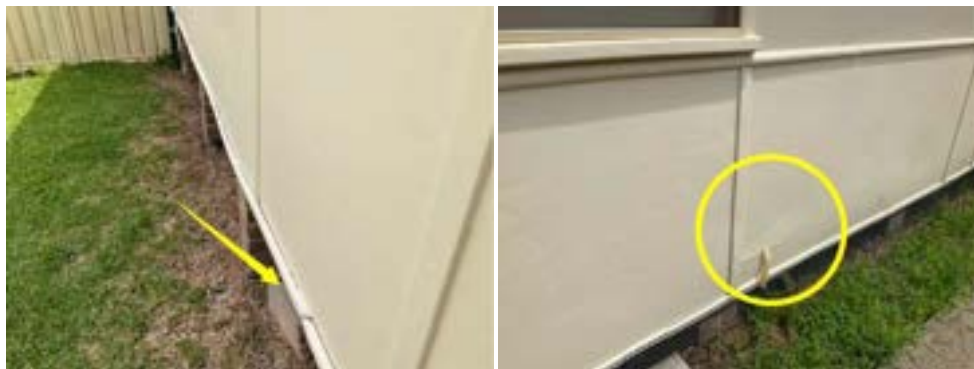
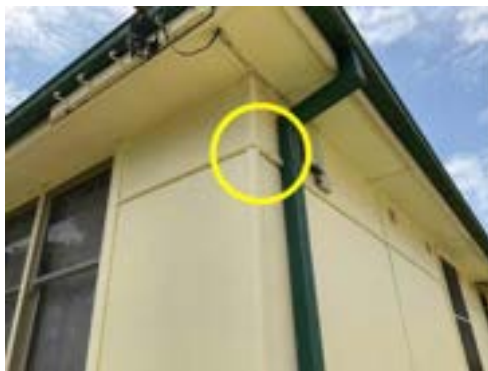
Paneling/cladding damaged. Have a suitably qualified tradesman assess and repair.

Minor decay and separation was noted to the external wall trims. We recommend replacement or maintenance of all affected timbers.

Minor cladding damage observed. This should be repaired so as to avoid moisture ingress and pests entry.

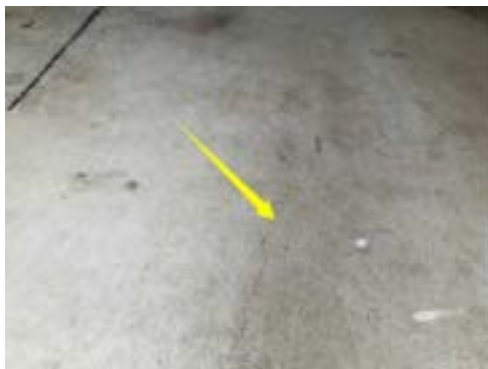
### **Floor Findings**

Minor hairline slab cracks - Note. Whilst these cracks appeared to be minor at the time of inspection, we strongly recommend you monitor these cracks and if worsening occurs contact a qualified concreter for further advice.

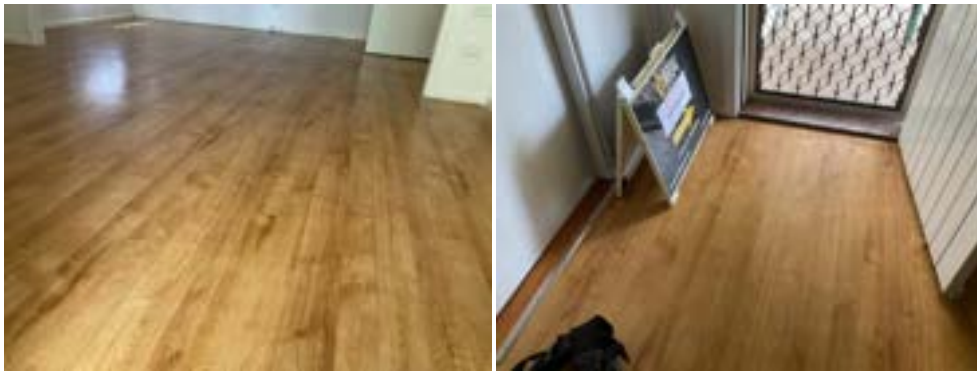
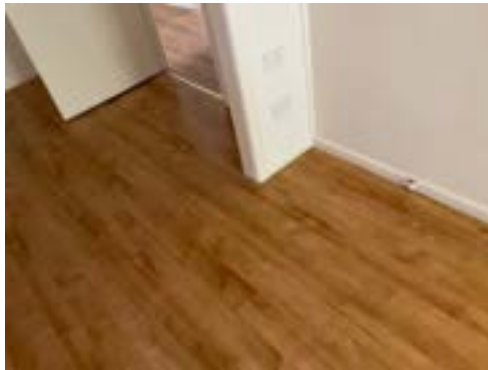
### **Flooring**

Sponginess bounce in flooring sections. There are many reasons for this. A qualified carpenter should be engaged for advice and recommendations.

Unevenness visible in floor. Possibly due to poor workmanship or excessive movement/settlement. A qualified carpenter should be engaged for advice and recommendations re levelling.

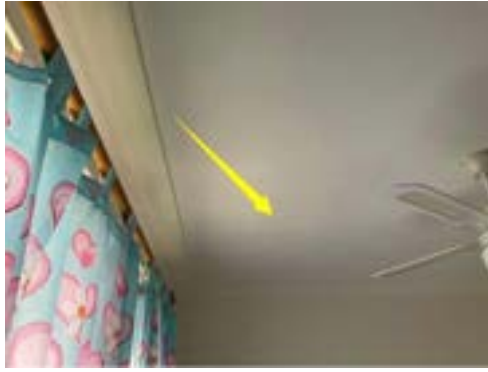
### **Ceiling**

Minor ceiling sagging - Requires repairs to prevent further collapse. Contact a qualified plasterer for repairs.

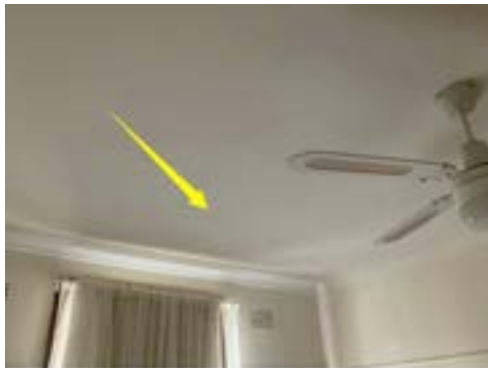
### **Ceiling**

Ceiling joint crack patching is evident. I recommend you contact a qualified painter for further advice and recommendations.

Minor ceiling sagging - Requires repairs to prevent further collapse. Contact a qualified plasterer for repairs.

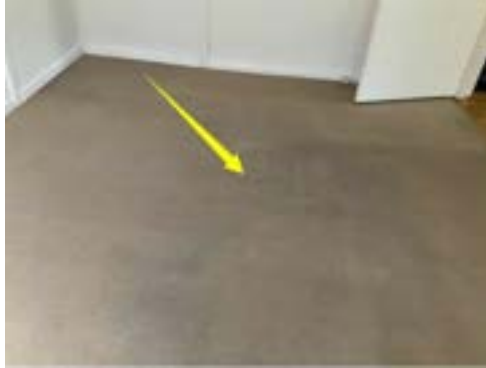
## Flooring

Unevenness visible in floor. Possibly due to poor workmanship or excessive movement/settlement. A qualified carpenter should be engaged for advice and recommendations re levelling.

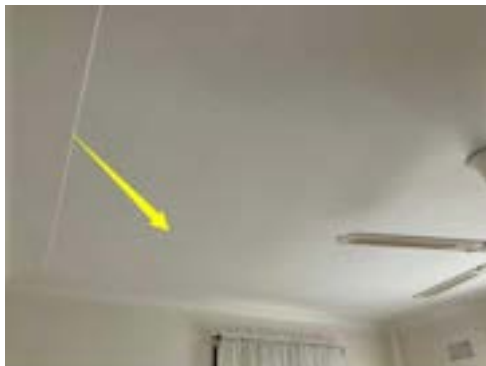
## Ceiling

Minor ceiling sagging - Requires repairs to prevent further collapse. Contact a qualified plasterer for repairs.

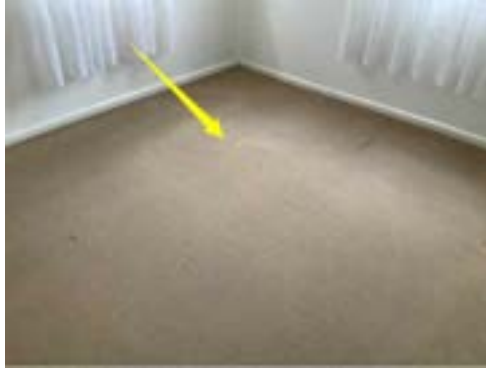
## Flooring

Unevenness visible in floor. Possibly due to poor workmanship or excessive movement/settlement. A qualified carpenter should be engaged for advice and recommendations re levelling.

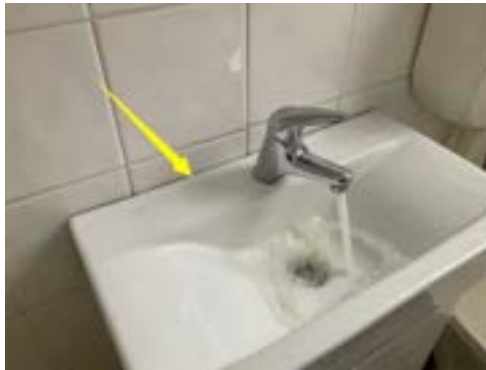
## Vanity/Sink/Taps

Deteriorated or missing sealant at wall and basin junction noted. Recommendation: Have sealed by a qualified plumber or a tiling contractor to prevent water access behind the wall.

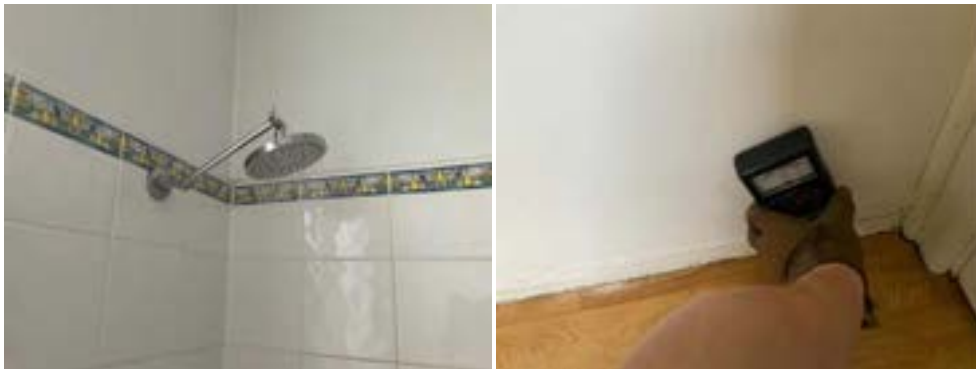
## Shower

Slightly high moisture readings were obtained on the wall linings adjacent bathroom/shower. This may be related to the shower recess/plumbing in wall cavity leaking or failed waterproofing membrane to the wet area.

Recommendations: Engage a plumber and a licensed waterproofer for advice and recommendations.

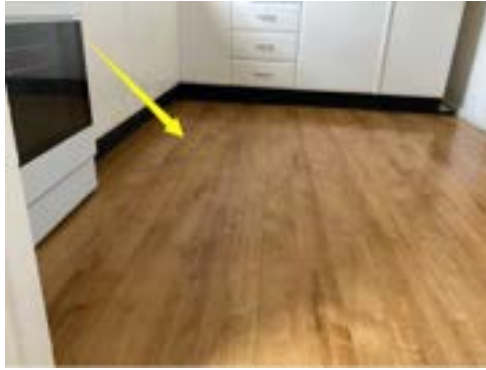
Borer damage to floor linings - Some weakened boards may require assessment/replacement.  
Recommendations: A qualified carpenter should be engaged for advice and recommendations.

Unevenness visible in floor - Floor linings may require removal to ascertain cause. Recommendations: A qualified carpenter should be engaged for advice and recommendations re levelling.

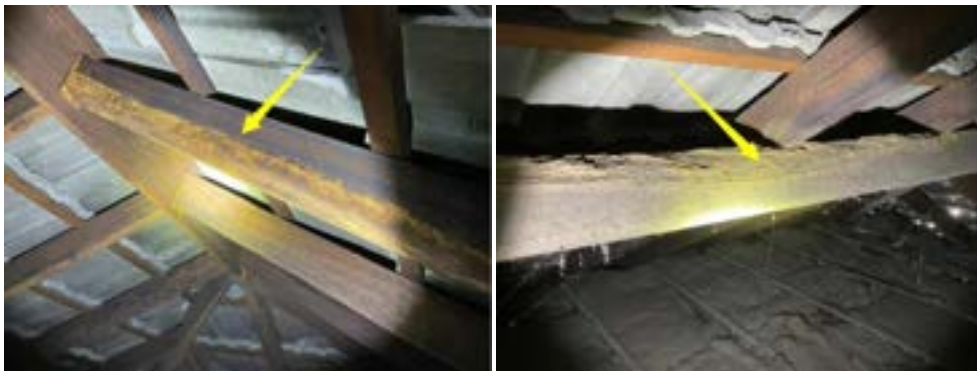
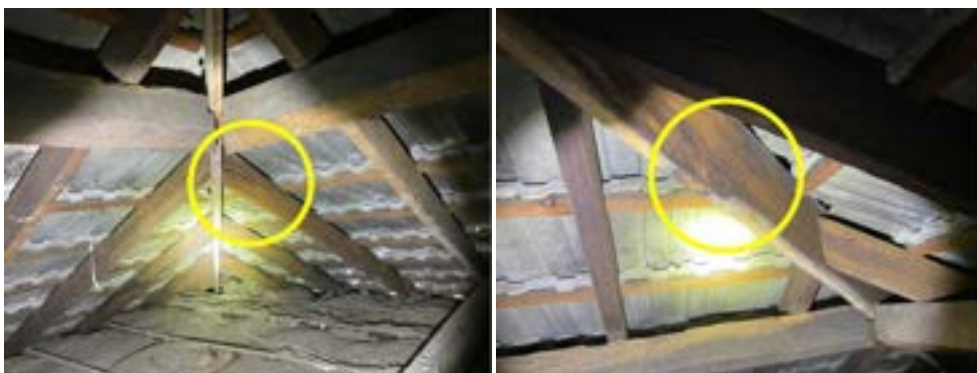
## Roof Framing Defects

Borer damage present in roof framing. Section may require replacement. A qualified carpenter should be engaged for advice and recommendations.

The rafter/split damaged. We recommend you engage a qualified roofing carpenter for further evaluation and advice.

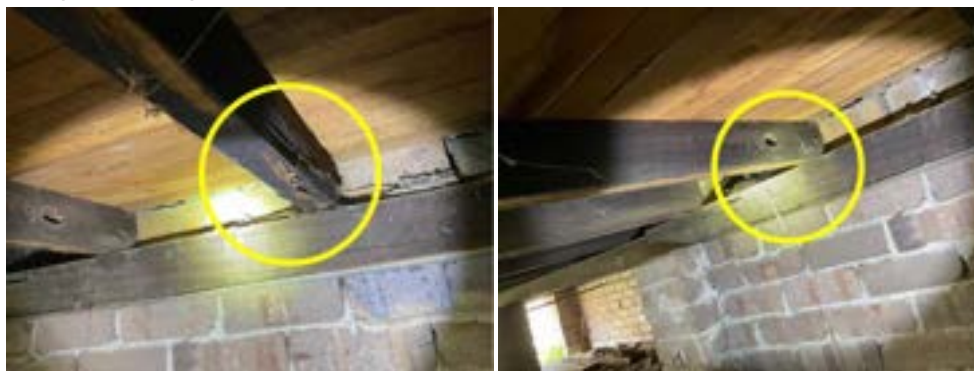
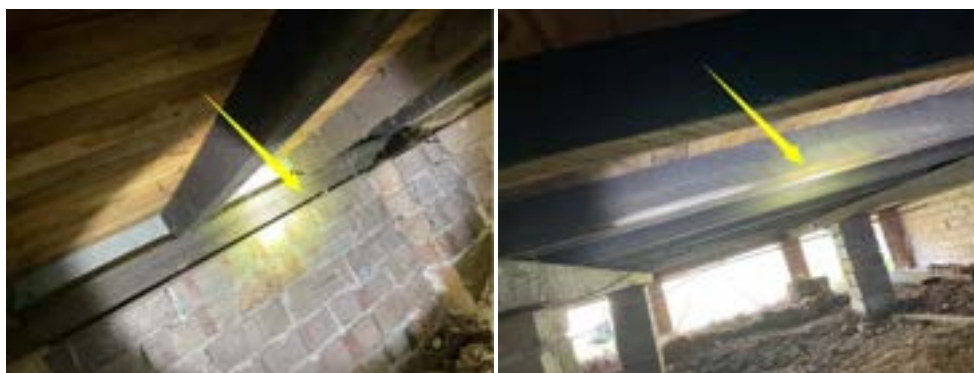
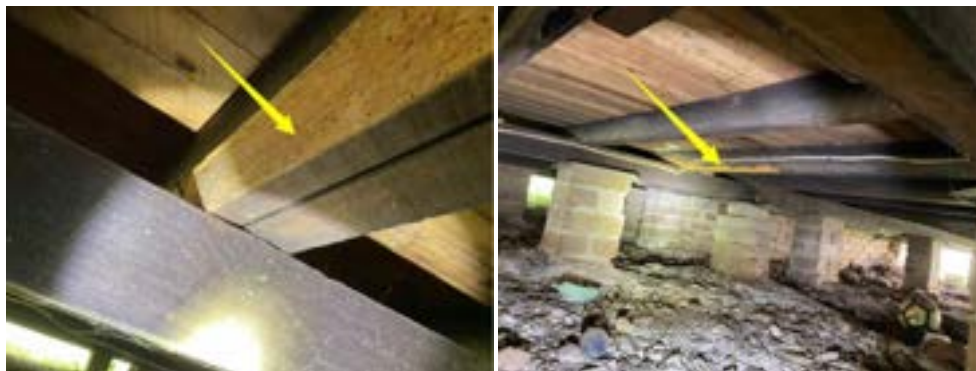
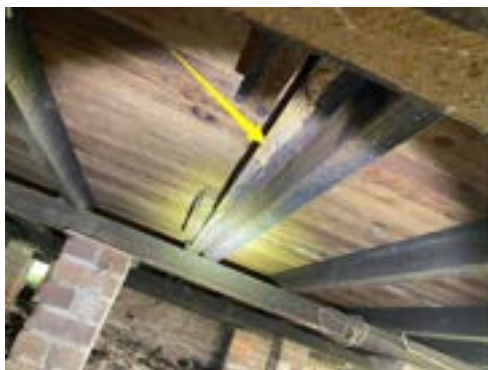
A bearer between 2 piers have been cut providing inadequate support for the floor. Contact a licensed builder for repairs.

Timber pest attack noted. See a licensed pest technician and a licensed carpenter for further evaluation and advice. Note that if this is a building inspection only we strongly recommend that you obtain a timber pest inspection prior to a decision to purchase. Where a combined report is ordered, please refer to the attached visual timber pest inspection report

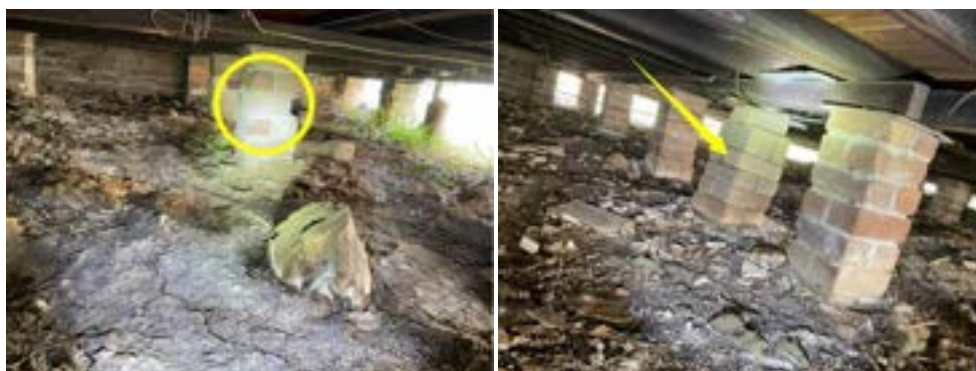
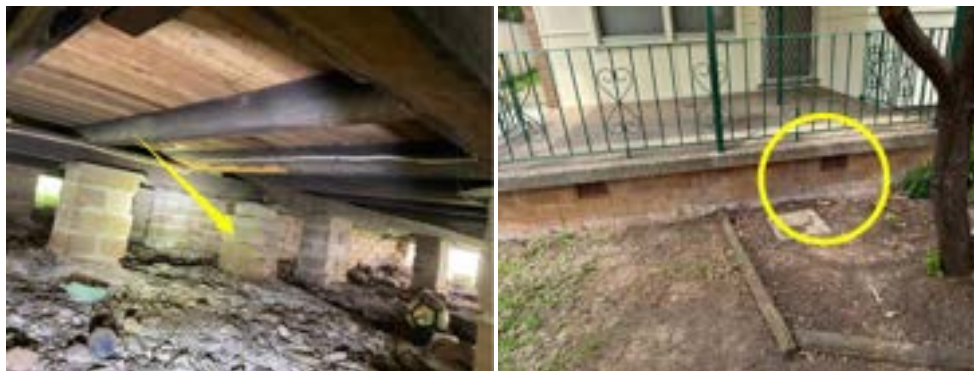
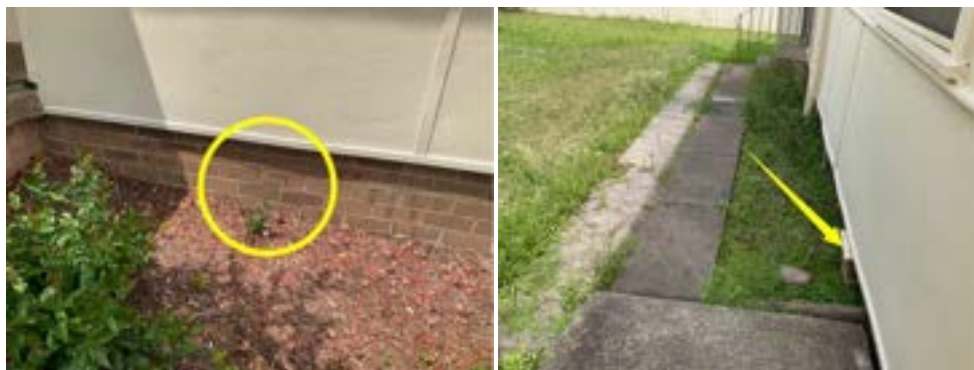
## Piers And Foundation Walls

Brick fretting to piers visible. (Bricks breaking to powder form from salts and minerals due to moisture) A qualified brick layer and drainage expert should be engaged for advice and recommendations.

Cracking was evident to the foundation walls. Underpinning may be required to prevent further movement and cracking. We recommend you contact a qualified brick layer and a practicing structural engineer for recommendations and advice.

Pier/s are loose and can be pushed by hand providing little support to the structure. Contact a qualified brick layer for urgent repairs.

Evidence of minor subsidence (Sinking) was noted to the footings/piers that will require re packing or re building.

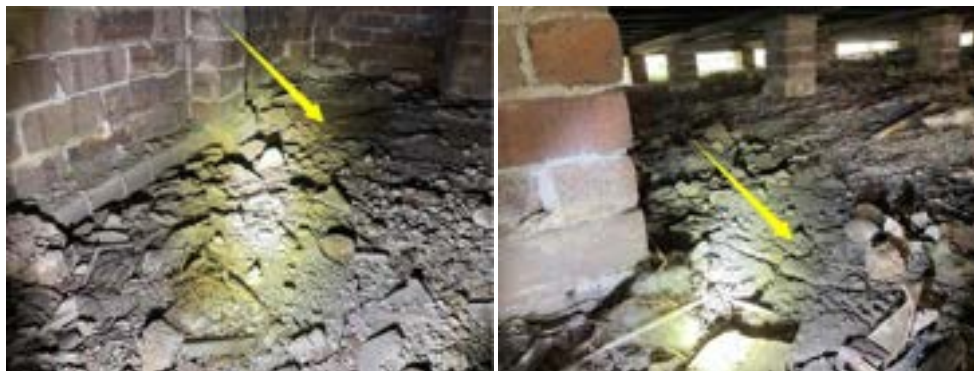
## Dampness

Though dry at the time of inspection there is evidence of previous water ingress in sub floor. This is likely to happen again during periods of heavy rain. Further assessment and rectification is required as this may cause possibly create/add further footings problems and settlement to piers.

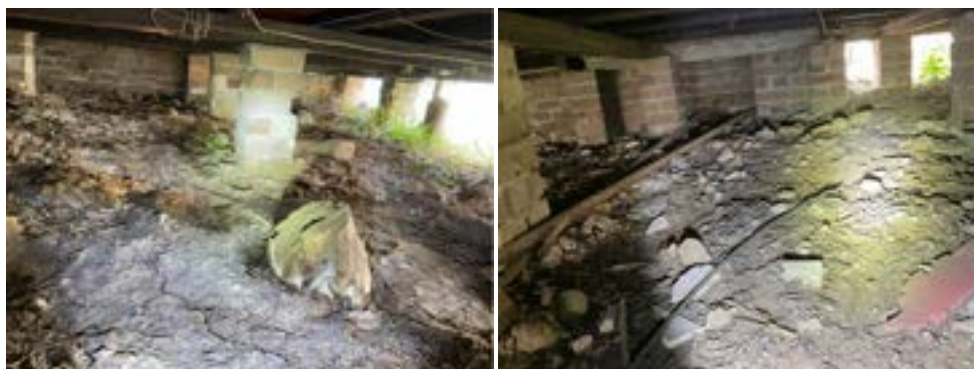
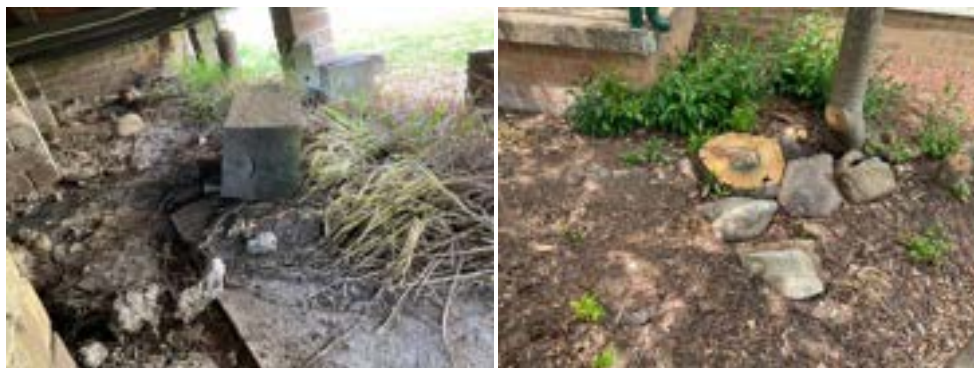
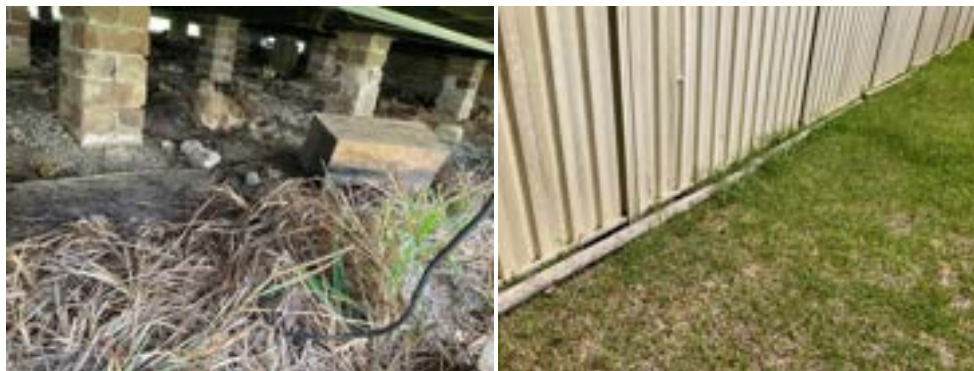
There are timber sleepers in the garden. Termites love nesting below timber sleepers as it provides a good food source while also providing protection for the nest. It is recommended that all timber sleepers be removed or replaced with a non-susceptible product as they are conducive conditions for termites.

Tree stump/s are located at the site. These need to be removed by a suitably qualified tradesperson as they are conducive conditions for a termite nest.
