# Pre Purchase Building & Pest Report

**Besafe Group Pty Ltd**

We have been requested by the client to attend their property and carry out a quality inspection on the pre-pour slab preparation works for the in situ reinforced concrete member detailed in their architectural and engineering drawings, and thereafter to prepare an inspection report identifying any defects that exist in those preparation works, for which rectification of needs to be carried out prior to the slab being poured.

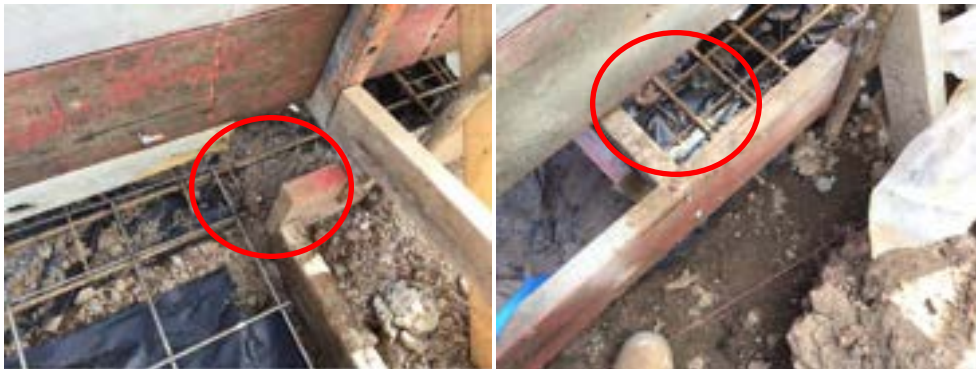
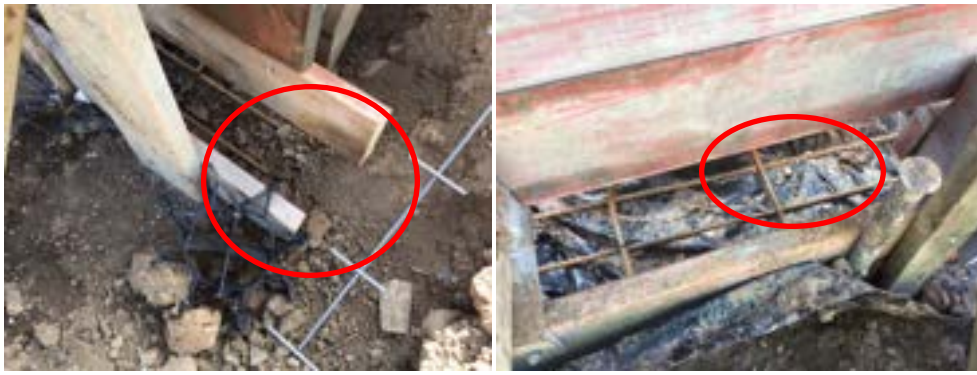
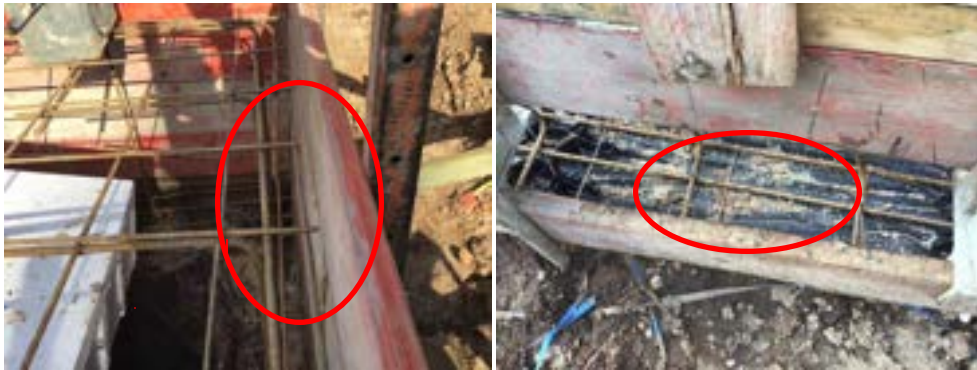
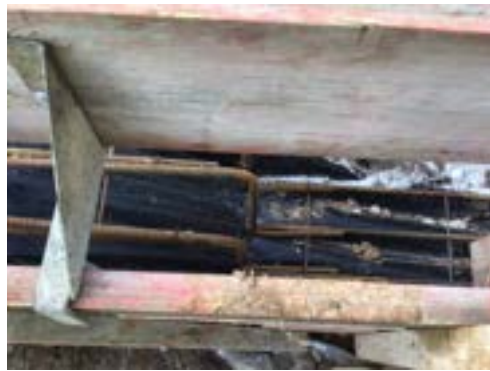
#### **Steel Reinforcement Installation**

The number of trench mesh are touching the ground (vapor barrier) and reinforcing mesh is too close to the form board or touching the board in some area.

All of the reinforcement that are not having adequate minimum cover must be rectified prior to concrete being poured.

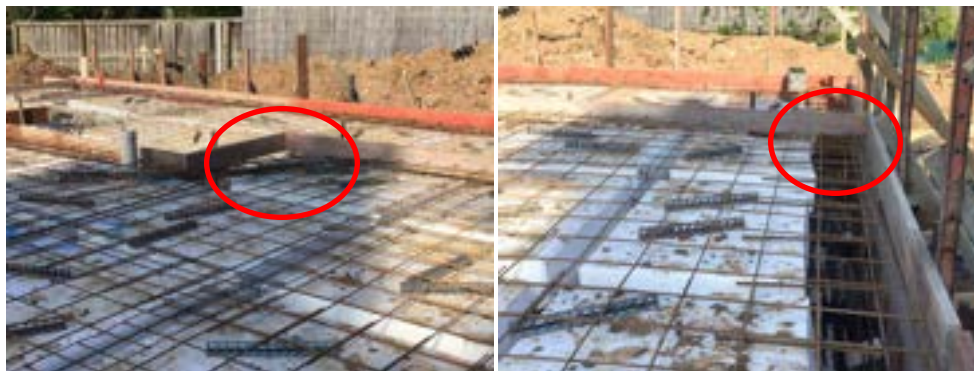
### **Steel Reinforcement Installation(1)**

In some area the reinforcement mesh is sagging well below the finish height of 20mm below the top of the concrete as per engineering plan.

This mesh should be supported with timber diagonally across the boxing timber and holding up with wire or should be lifted it up into position while pouring concrete.

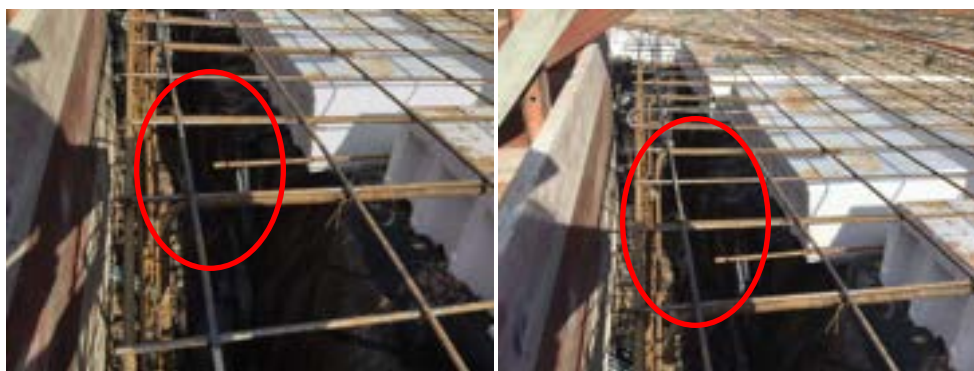
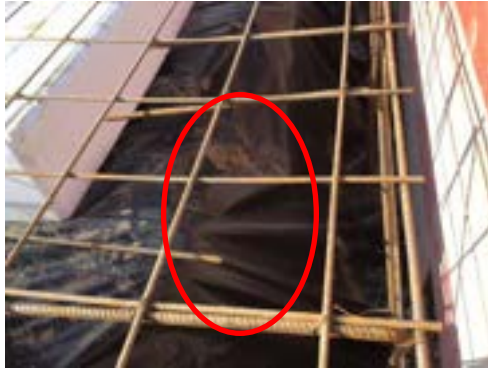
### **Internal Ribs Reinforcement Running Short**

Internal Rib reinforcing bar does not across the full width of the perimeter mesh. The BCA Part 3.2.3.2 Steel Reinforcement required that 'at the "T" intersections, the Rib steel reinforcing bars must over-lap full width of the perimeter mesh or overlap to the Z bar.

All of the reinforcing bars will need to be amended and confirmed as being fully lapped and tied to the perimeter mesh, prior to any concrete being poured

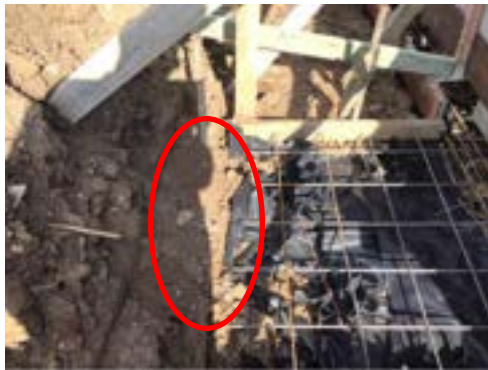
### **Cleaning required**

The soil around formwork has collapsed into the boxing area and need to be removed prior to pouring concrete.

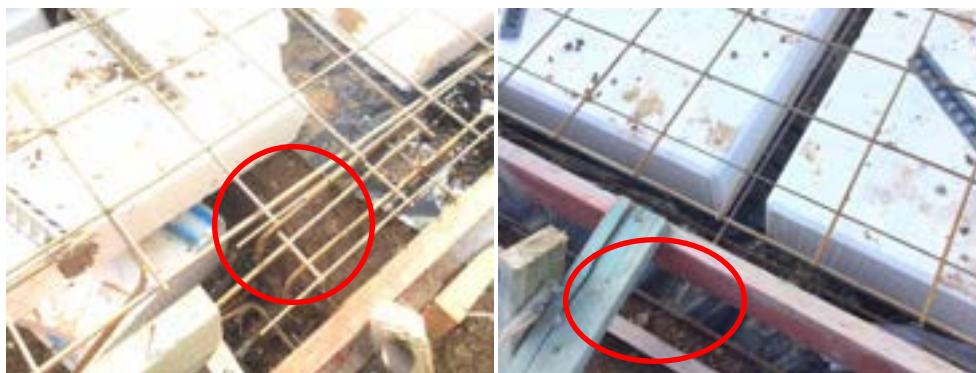
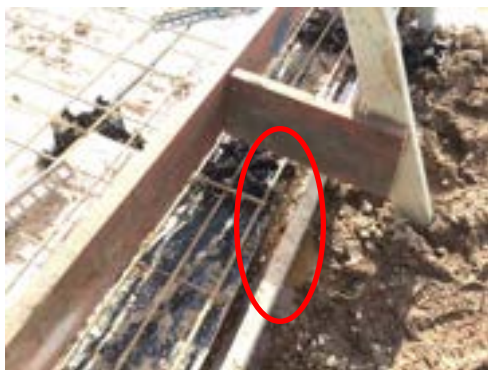
#### **Vapour Barrier Installation**

The vapour barrier is short to the edge of the footing and not overlapped.

The BCA Part 3.2.2.6 requires "The damp-proofing membrane must be placed beneath the slab so that the bottom surface of the slab is entirely underlaid and extends under edge beams to finish at ground level"

The vapour barrier to the referred area must be lapped and sealed, so that will extend to the finish ground level.

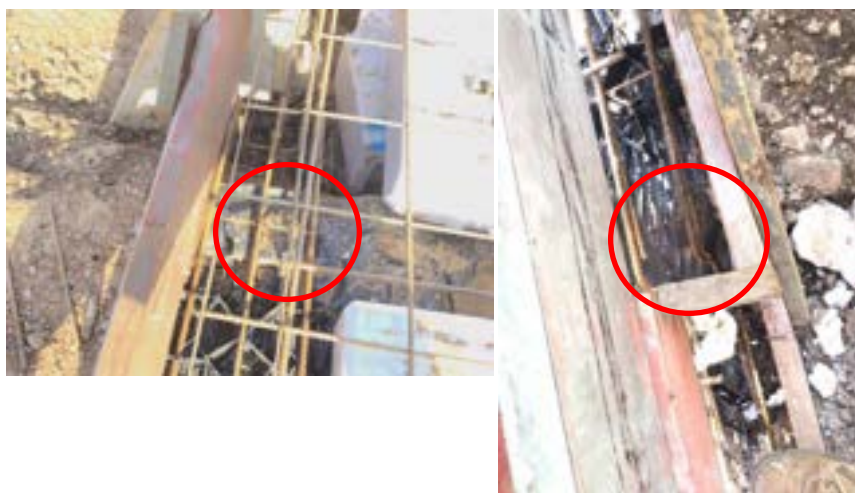
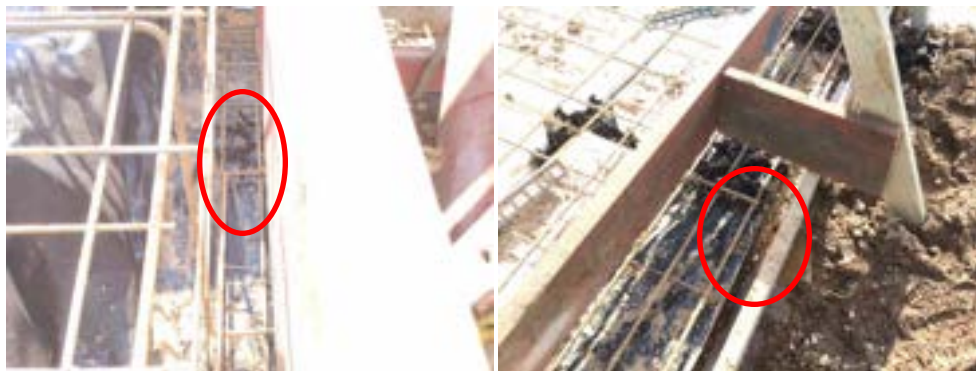
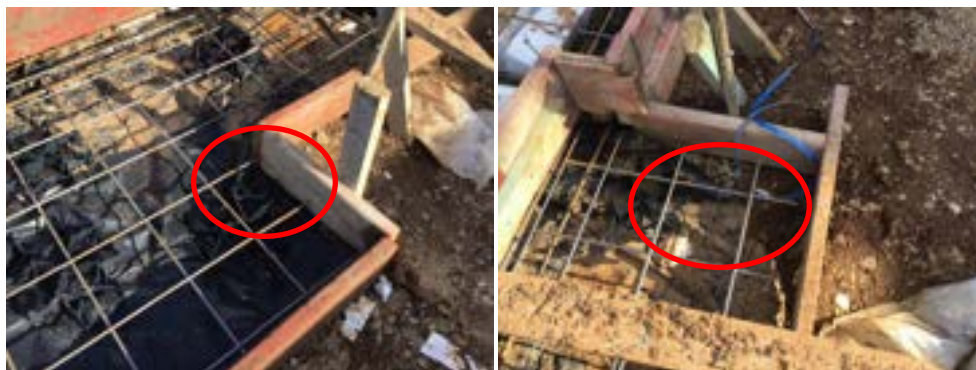
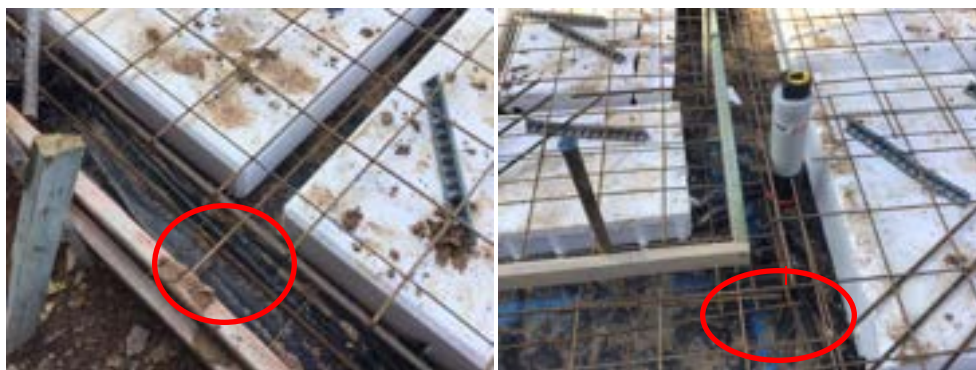
### Steel Reinforcement Installation

The number of trench mesh are touching the ground (vapor barrier) and reinforcing mesh is too close to the form board or touching the board in some area.

All of the reinforcement that are not having adequate minimum cover must be rectified prior to concrete being poured.

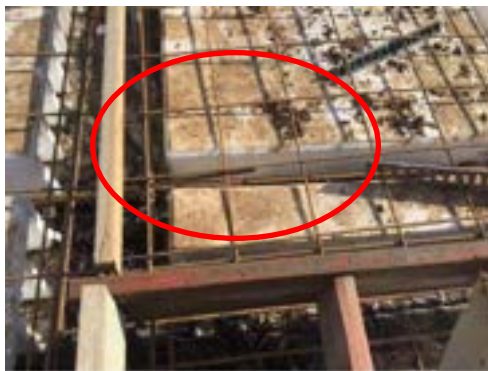
### **Steel Reinforcement Installation(1)**

The reinforcement mesh is finished well below the finish height of 20mm below the top of the concrete as per engineering plan.

This mesh should be supported with bar chair or with timber diagonally across the boxing timber and holding up with wire.

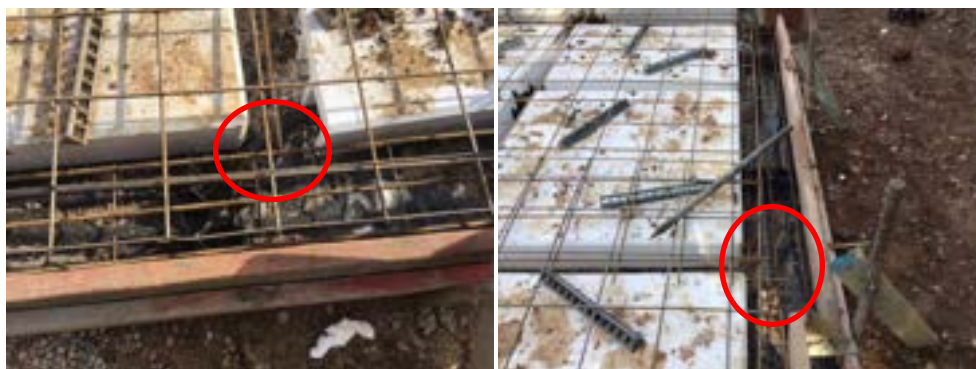
### Internal Ribs Reinforcement Running Short

Internal Rib reinforcing bar does not cross the full width of the perimeter mesh. The BCA Part 3.2.3.2 Steel Reinforcement required that 'at the "T" intersections, the Rib steel reinforcing bars must over-lap full width of the perimeter mesh (trench mesh).

All of the reinforcing bars will need to be amended and confirmed as being fully lapped and tied to the perimeter mesh, prior to any concrete being poured
