# Dilapidation Report

**Besafe Group Pty Ltd**

Report/Agreement # 19122203343951

Inspection Date: 19 Dec 2022

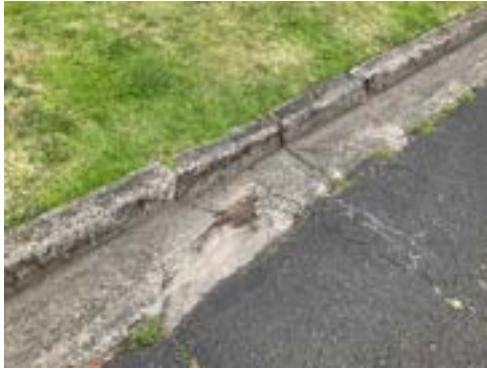
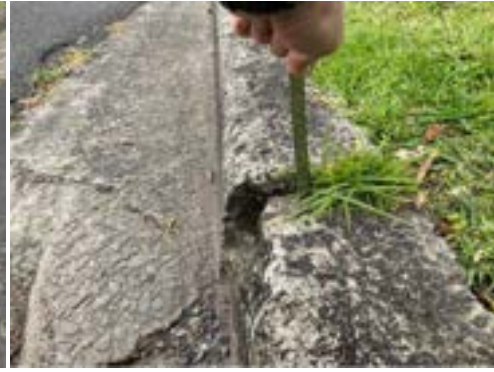
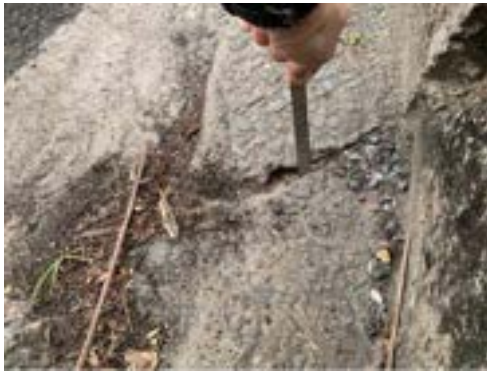
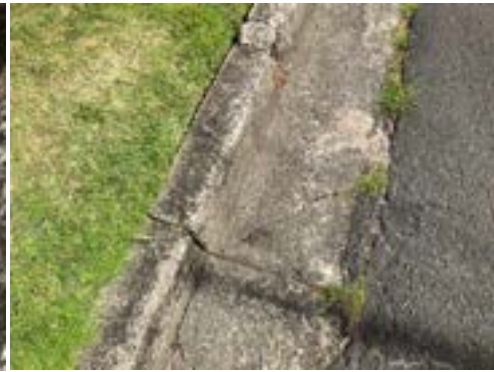
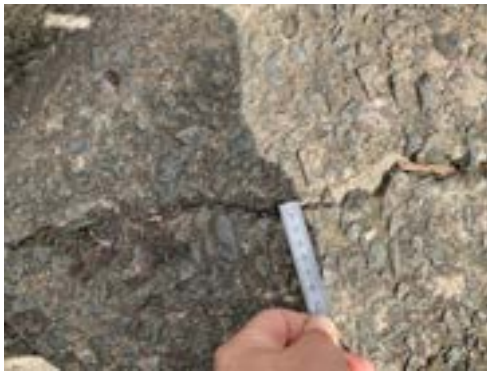
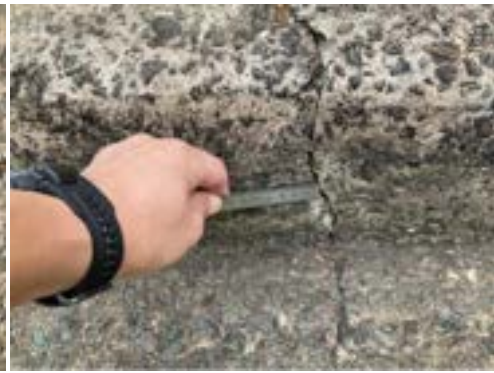
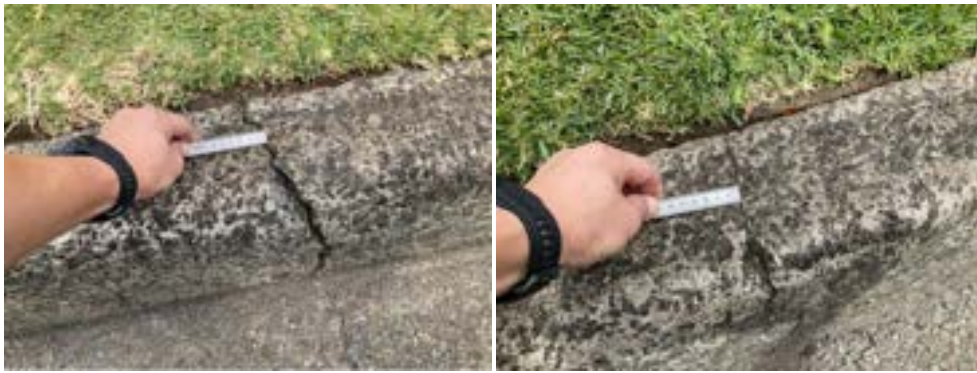
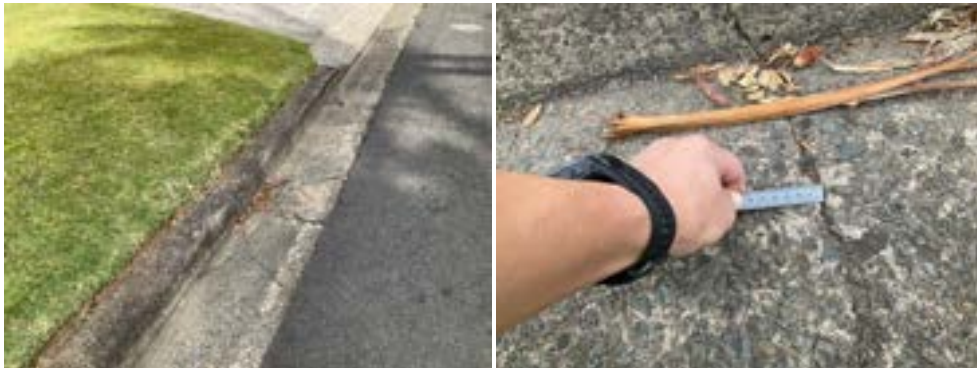
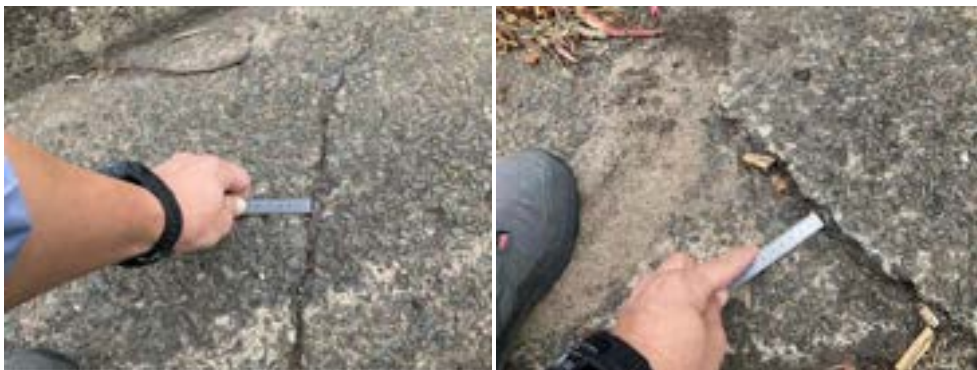
### Condition Of Surfaces Along No 30. 32

#### **Path/Kerb**

Aged cracking 1mm - 5mm

Section of kerb offsetting approx. 30mm.

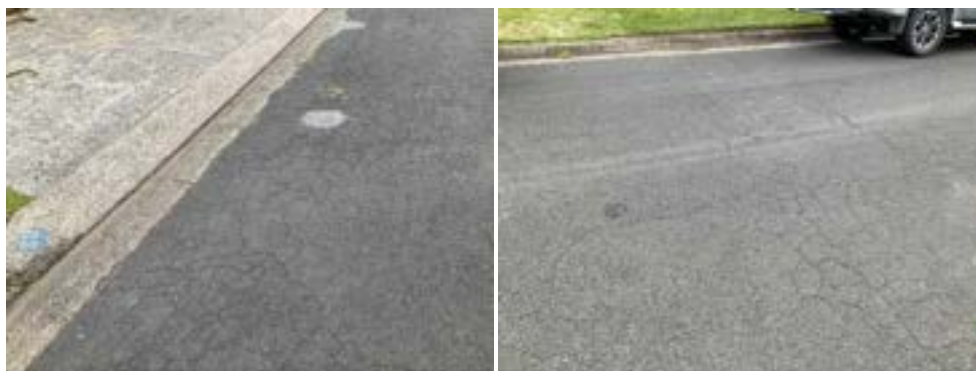
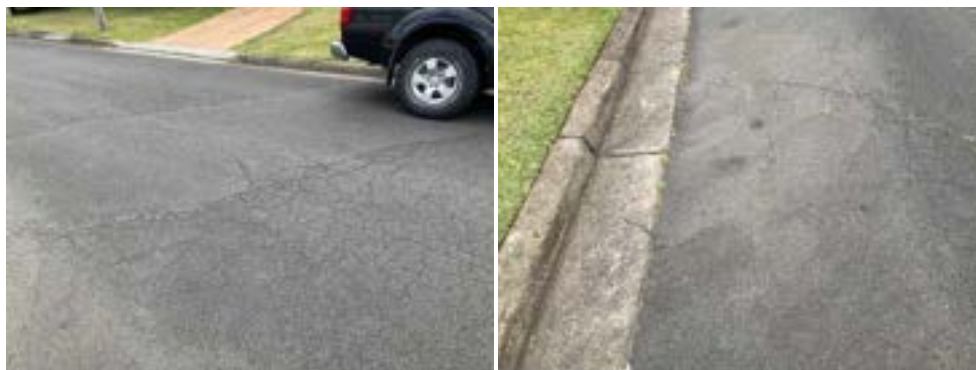
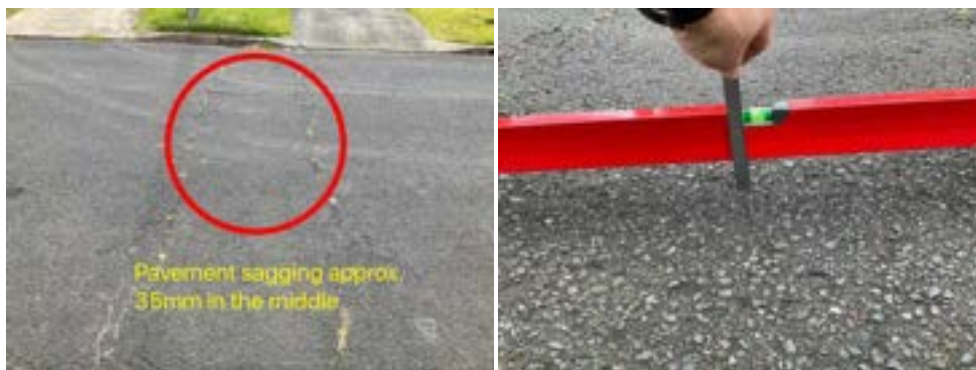
## Road

Fatigue cracking noted. Generally interconnected cracks and various cell sizes.  
Pavement sagging approximately 35mm in the middle.

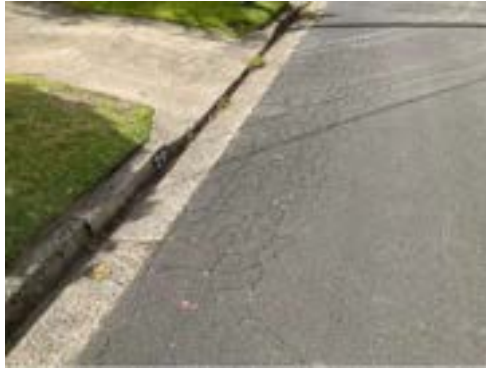
## Condition Of Surfaces Along No 29

Fatigue cracking noted. Generally interconnected cracks and various cell sizes.

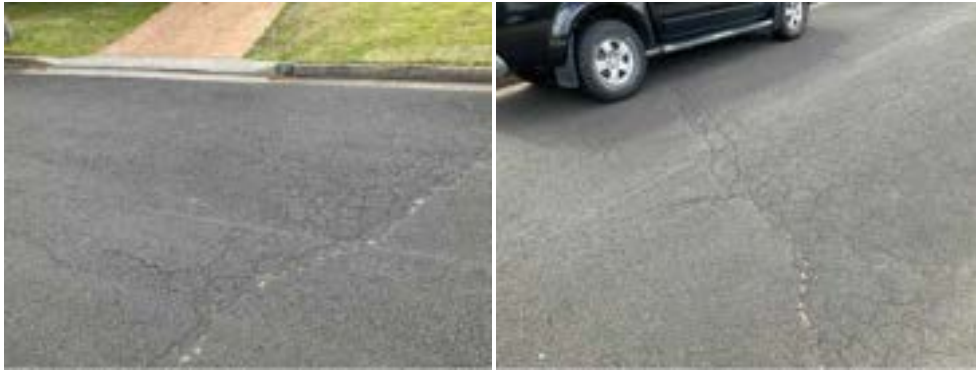
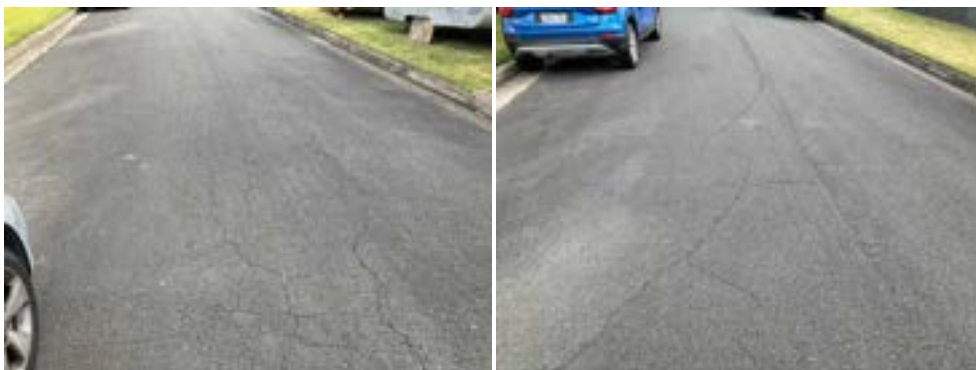
### Condition Of Surfaces Along No 31

Fatigue cracking noted. Generally interconnected cracks and various cell sizes.  
 Unconnected cracks running along the pavement in the middle.  
 Unconnected diagonal cracks.

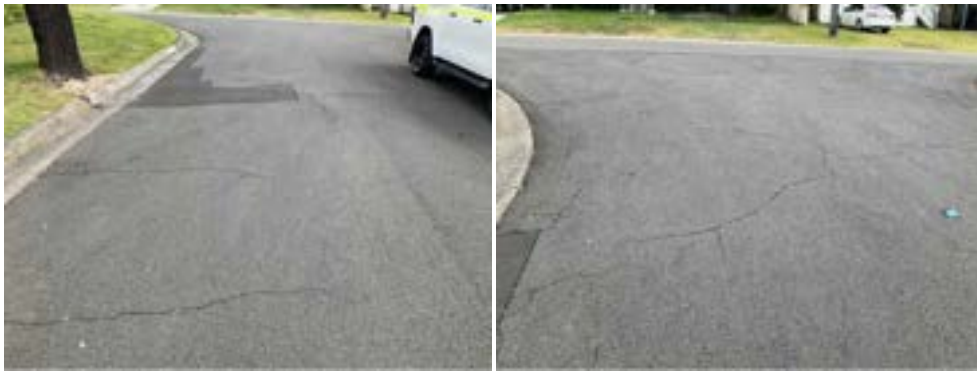
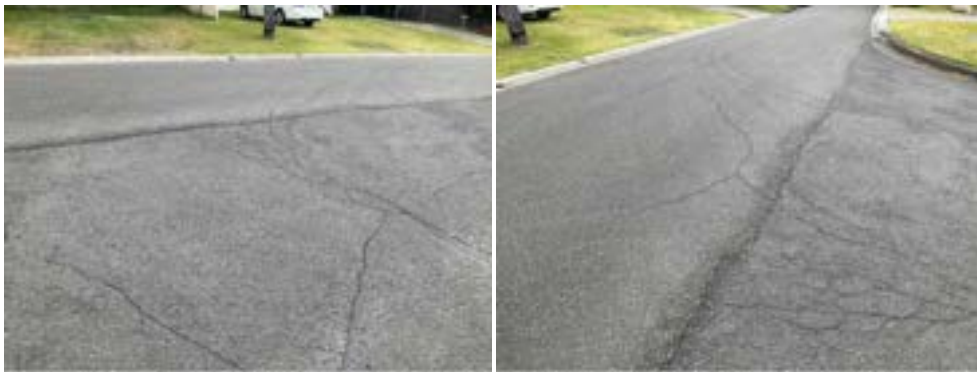
### Condition Of Surfaces Along Near Junction

Unconnected cracks running along the pavement in the middle.  
 Unconnected diagonal cracks.

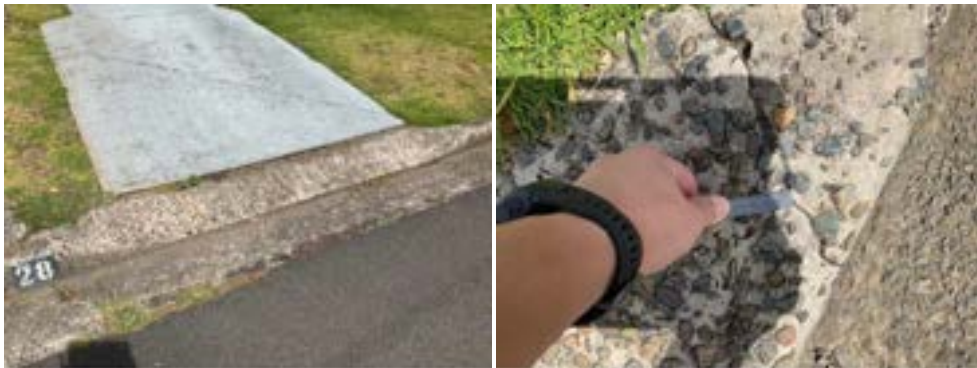
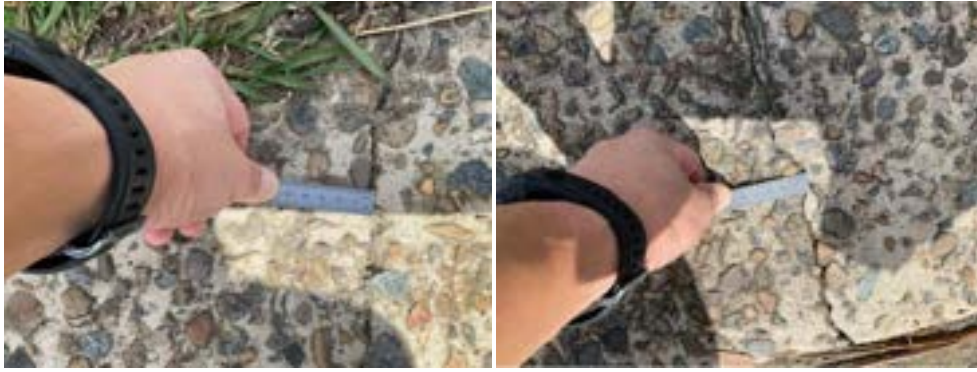
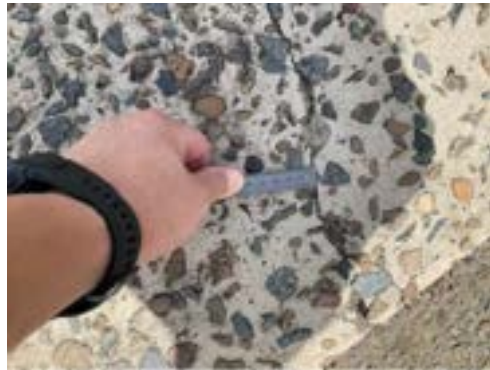
### Condition Of Surfaces Along No 28

#### **Crossover**

Cracking 1mm - 5mm

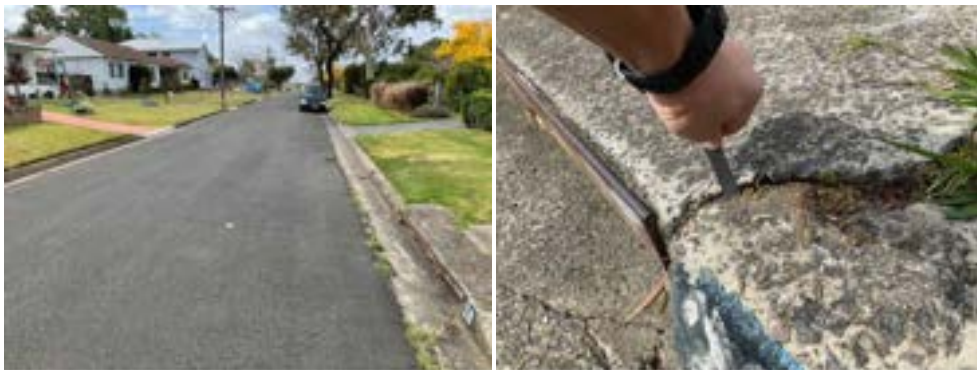
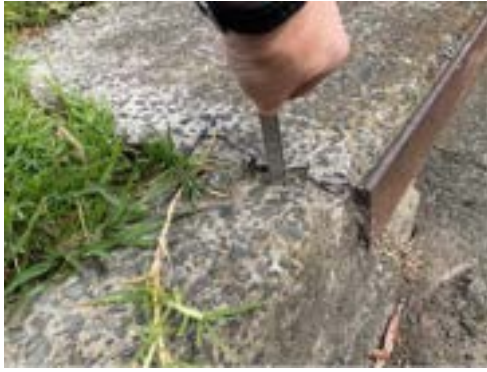
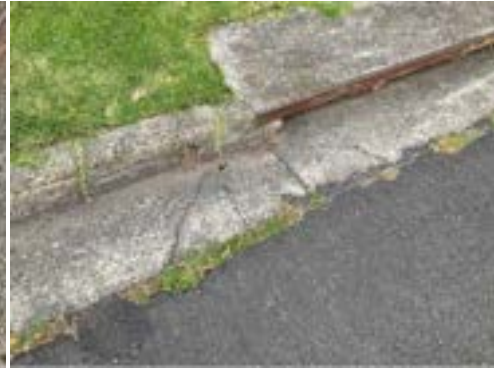
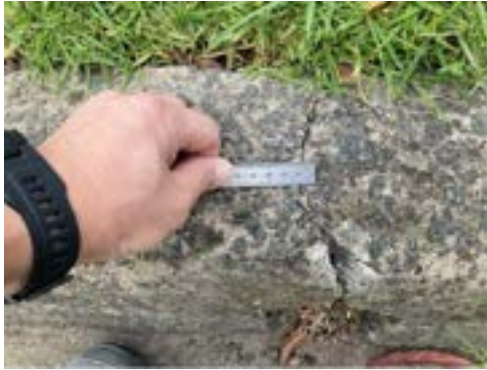
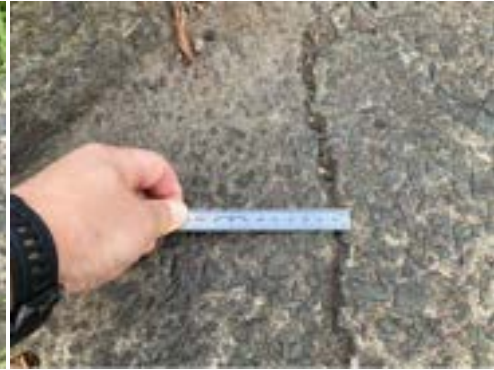
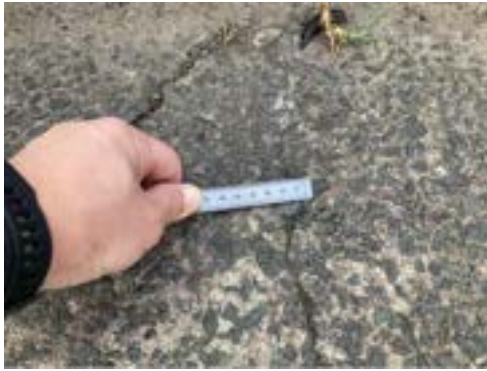
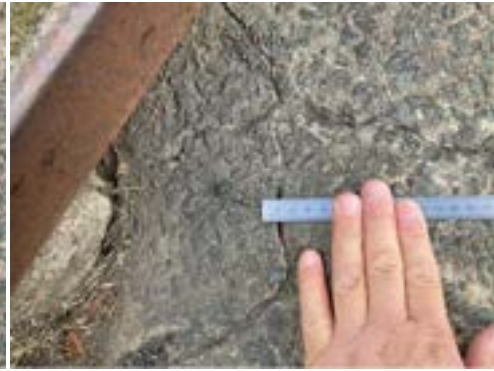
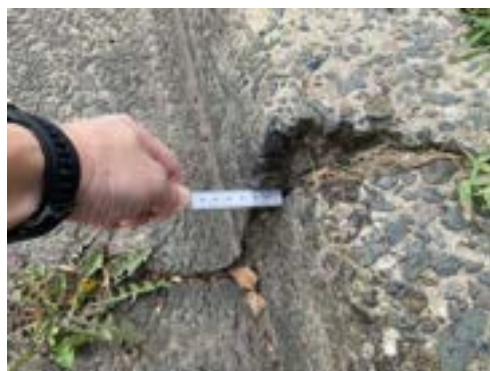
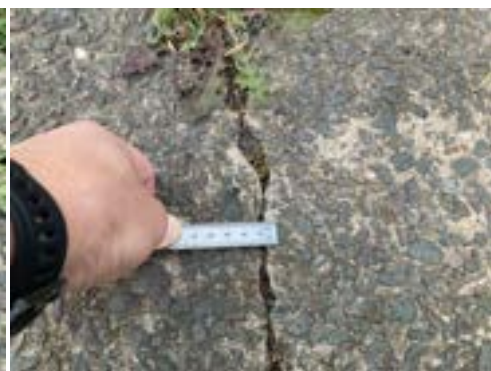
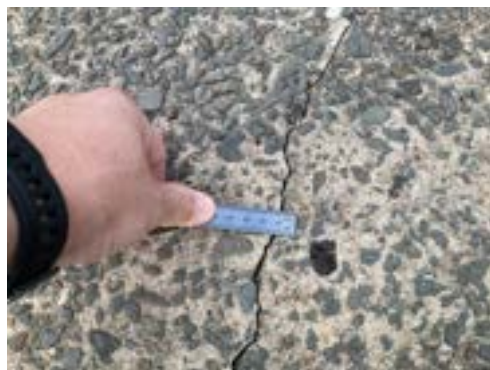
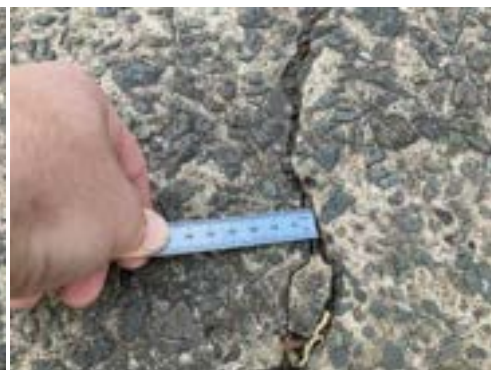
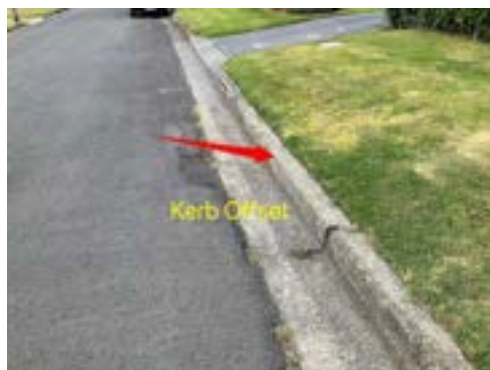
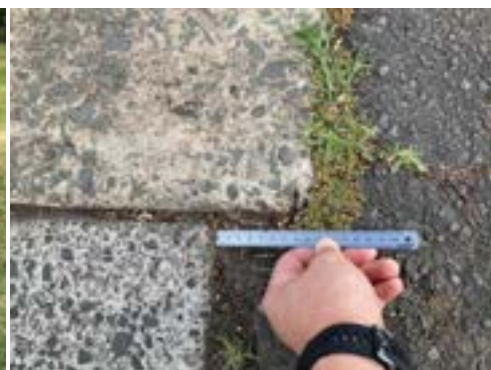
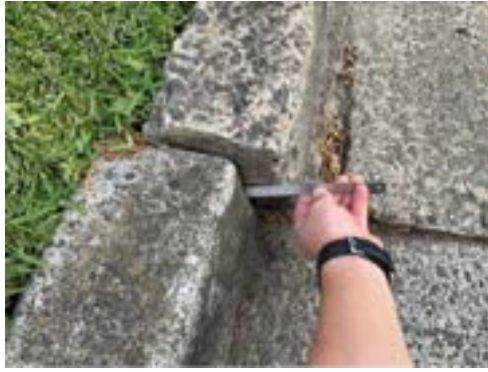
**Path/Kerb**

Aged cracking 1mm - 5mm in various areas.  
Section of kerb offsetting approx. 30-50mm.

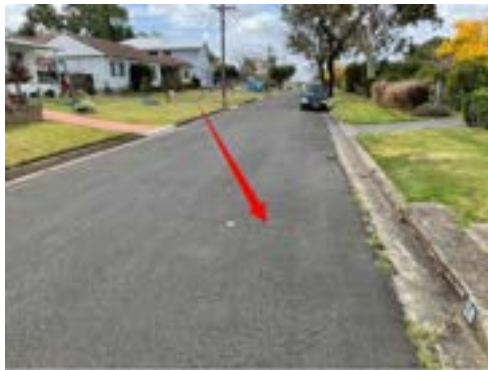
Cracking 1mm - 5mm

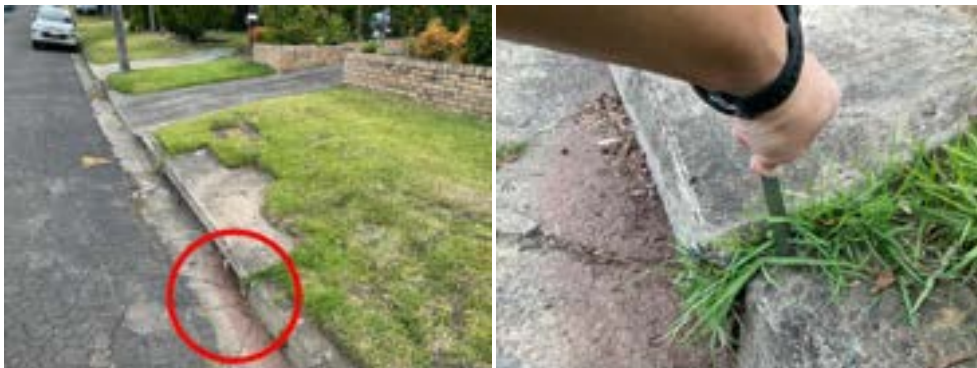
**Condition Of Surfaces Along No 27**

Aged cracking 1mm - 5mm

Kerb drainage offsetting approx. 30-40mm.

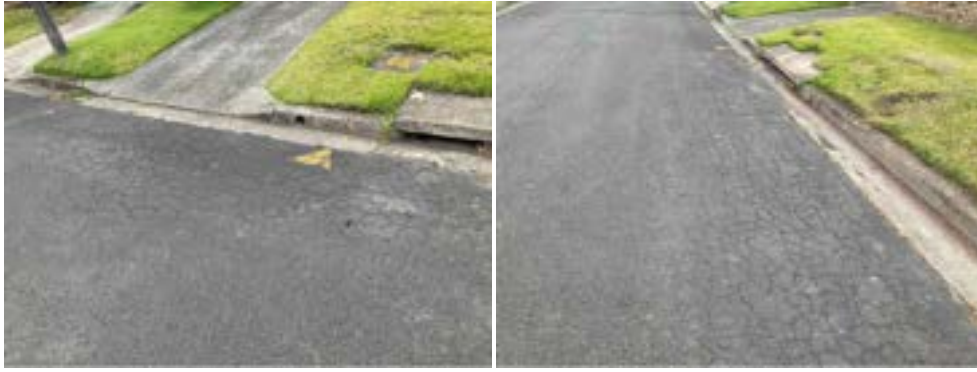
Fatigue cracking noted. Generally interconnected cracks and mainly small cell sizes.

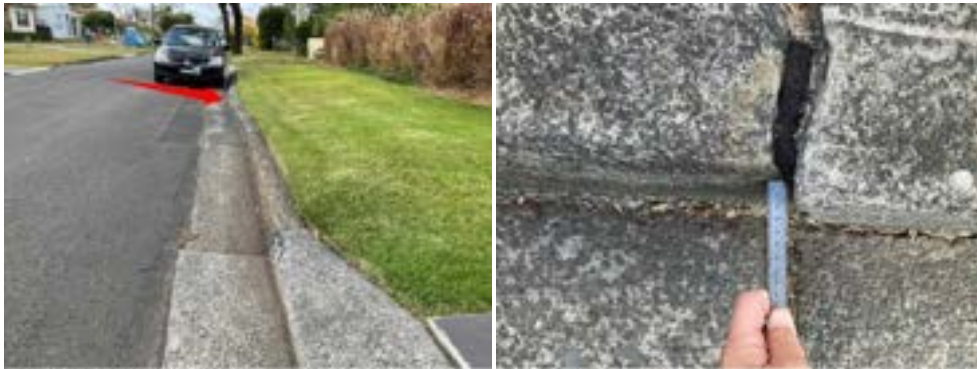
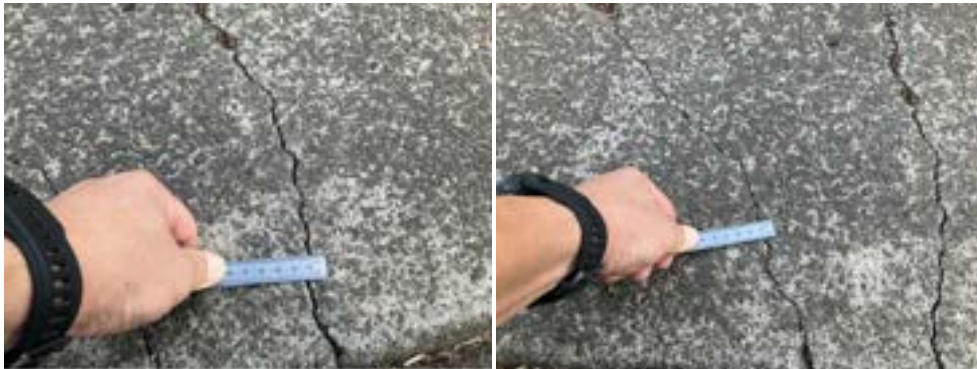
**Condition Of Surfaces Along No 26**

Aged cracking 1mm - 5mm in various area.  
Section of kerb offsetting

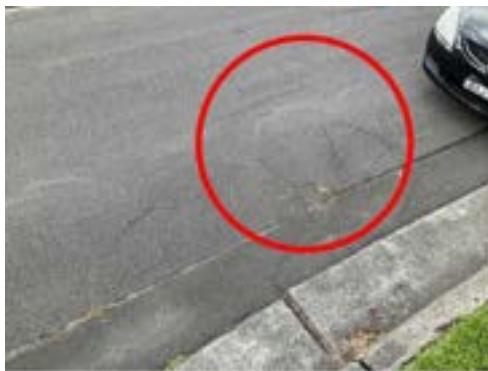
Cracking 1mm - 5mm

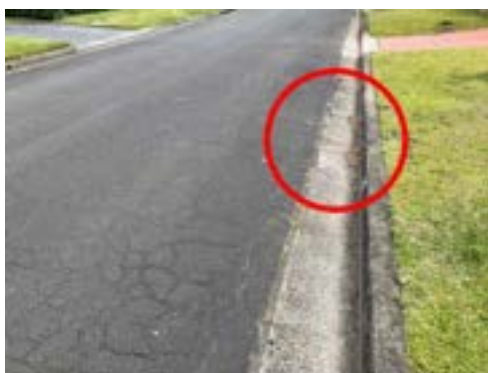
### Condition Of Surfaces Along No 25

Aged cracking 1mm - 5mm

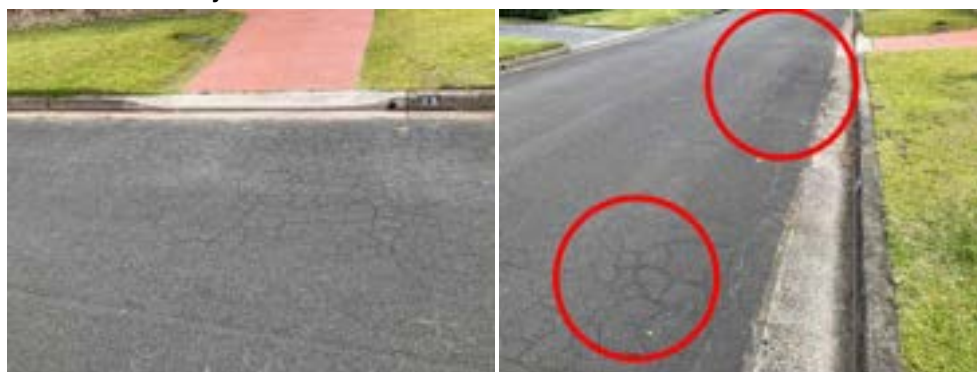
Fatigue cracking noted. Generally interconnected and various cell sizes.

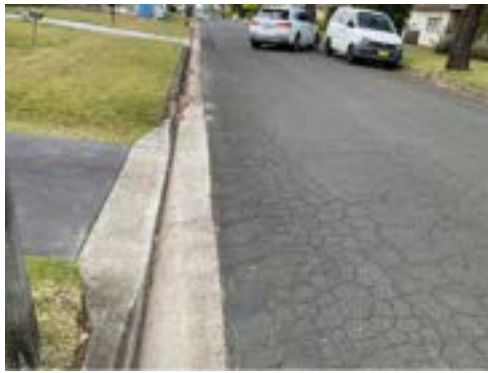
### Condition Of Surfaces Along No 23

Fatigue cracking noted. Generally interconnected and cell sizes are around 150-300mm.

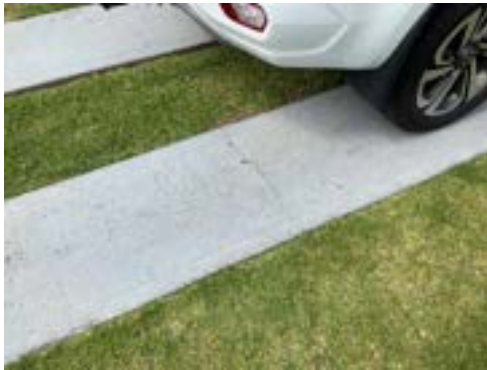
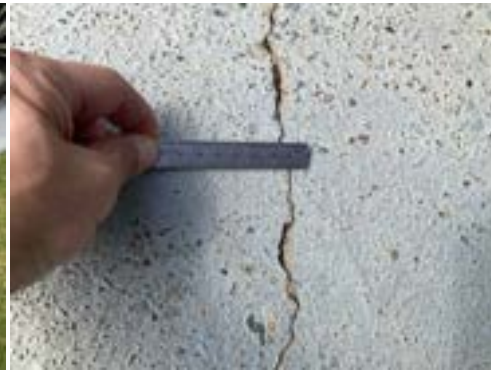
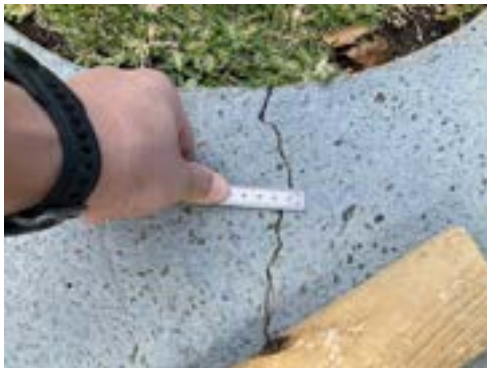
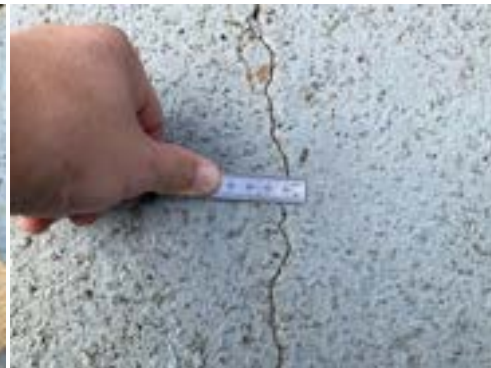
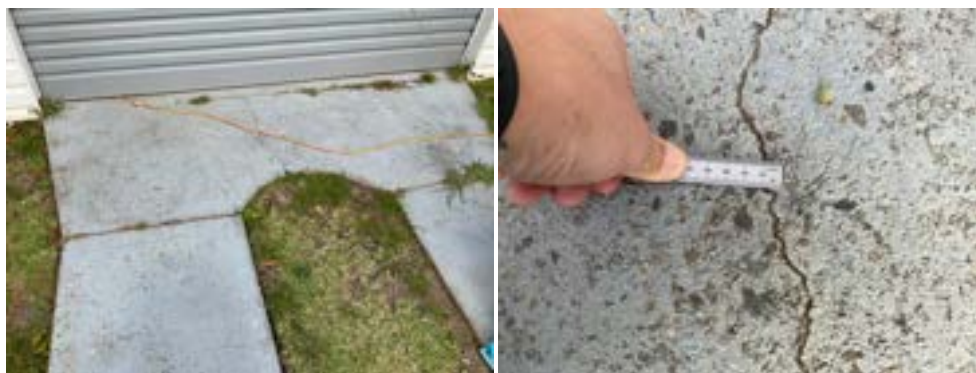
#### Driveway

Cracking 0.5mm - 1mm

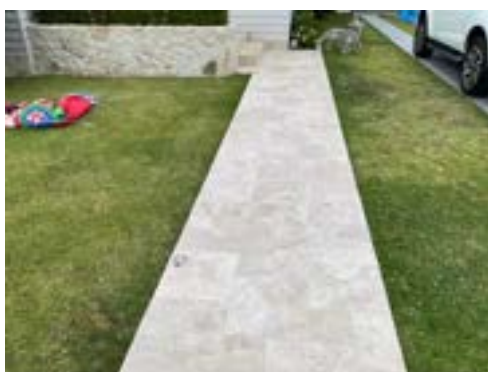
### Paths and Walkways

No Defects Noted

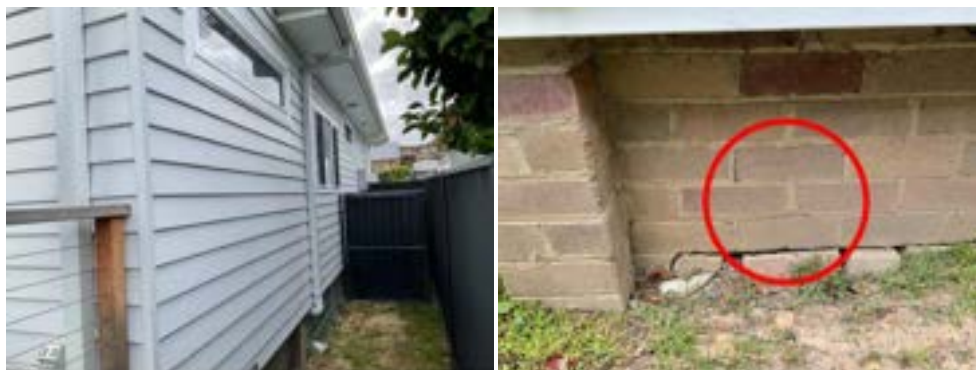
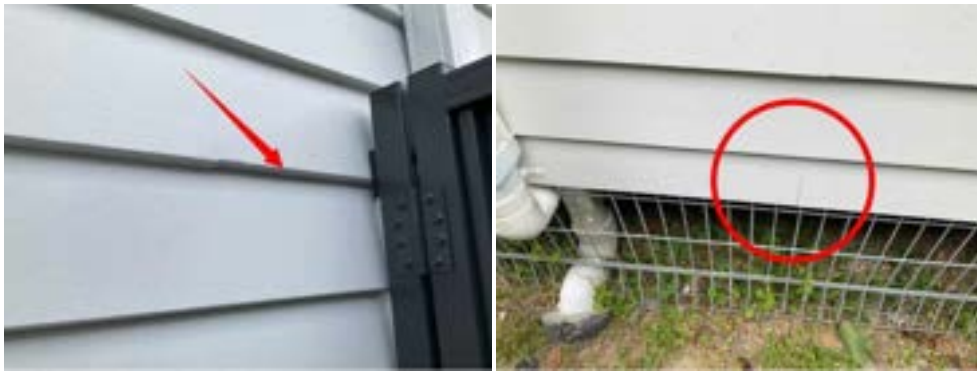
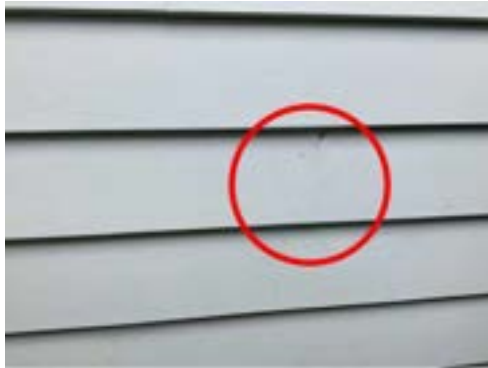
### North Elevation

Cracking 0.5mm - 1mm

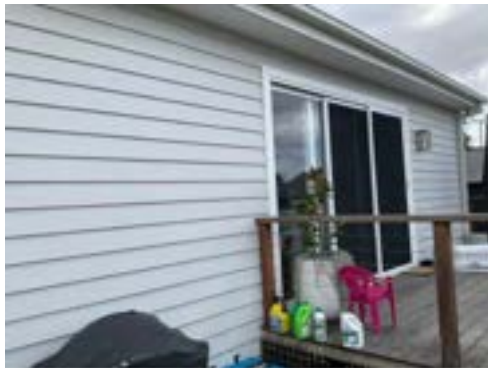
**East Elevation**

No Defects Noted

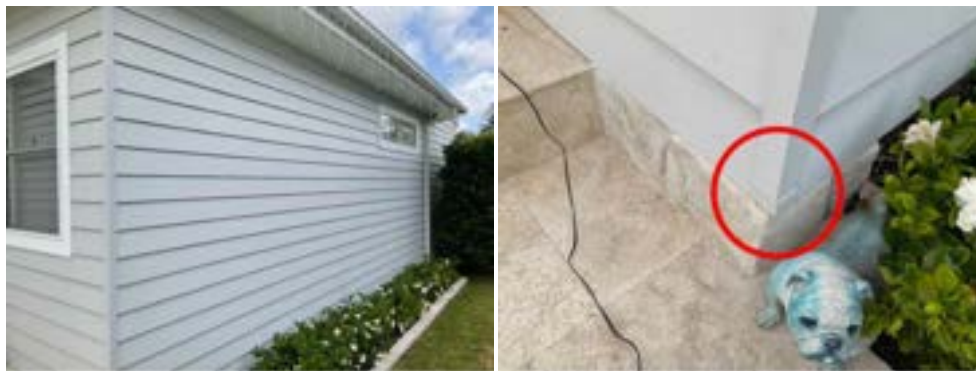
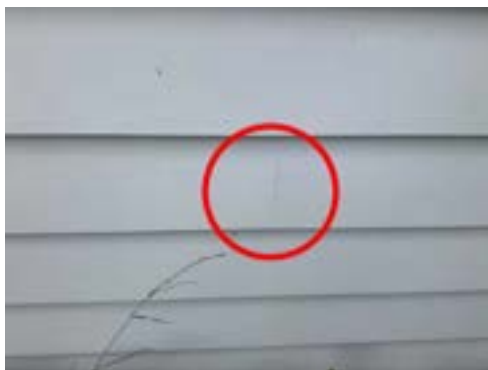
**South Elevation**

Appearance Crack Present

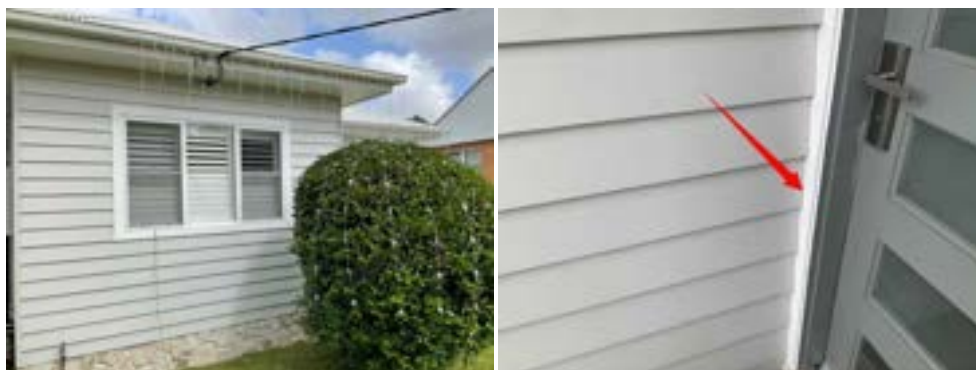
**West Elevation**

Appearance Crack Present
