!! !"#\$%&'()*+,-./:;<=>?@A B C D E F G H I J K L M N O P Q R S T U V W X Y Z [\] ^ _ ` { | } ~ ¡ ¢ £ ¤ ¥ ¦ § ¨ © ª « ¬ ® ¯ ° ± ² ³ ´ µ ¶ · ¸ ¹ º » ¼ ½ ¾ ¿ Fram & (Stage Report

Besafe Group Pty Ltd

Progress Inspection Report

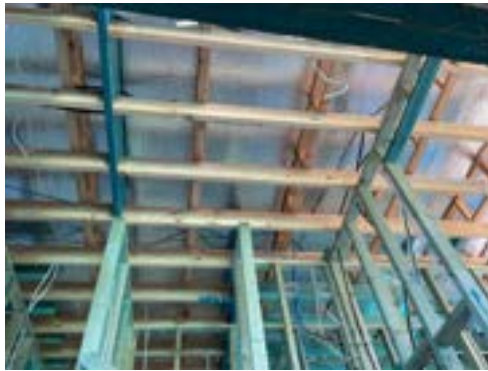
Sarking & Insulation

When installing metal roofing, the insulation should provide to reduce heat gain and reduce noise from rain and thermal expansion and contraction. Thus, the blanket and foil insulation installed directly under the cladding is the best option to achieve above requirements. You should refer to the BASIX requirements of thermal insulation materials.

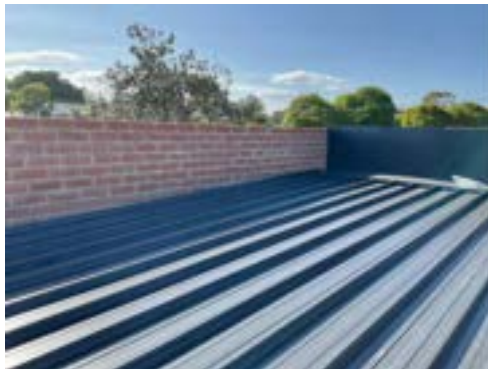
Roof Cladding

In progress. Recommend re-inspection when completed.

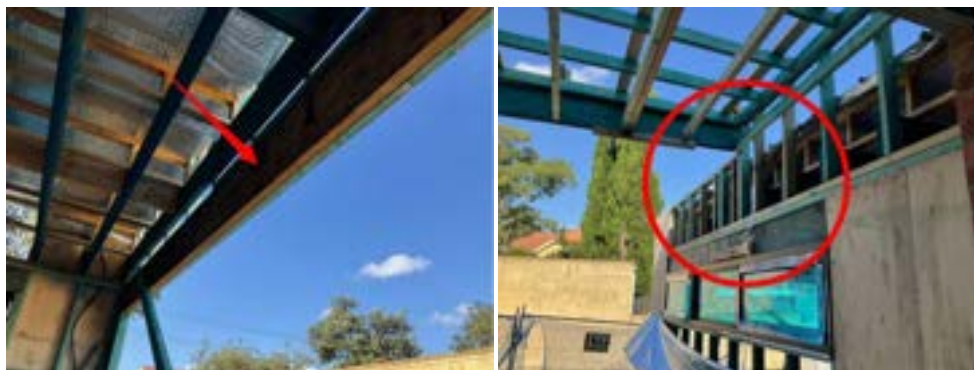
Lintels

The lintel size should be selected with AS 1684 and additional lintels required if any load applied to the lintel.

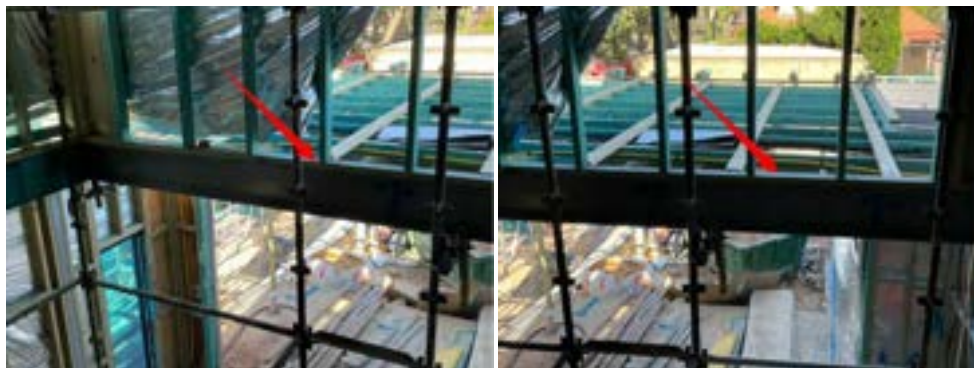
Frame Fixings

The bottom plate is not fixed/fastened to the steel beam. Self drilling tek screws should be used to secure the bottom plate.

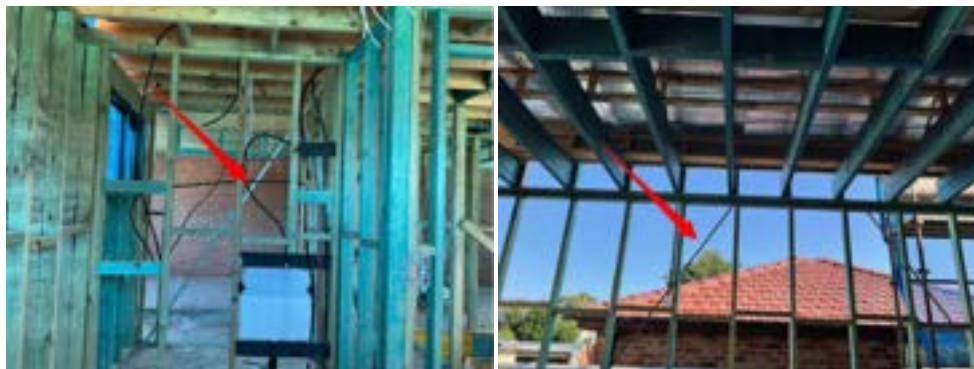
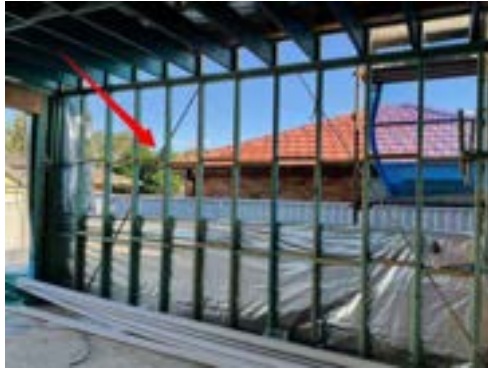
Wall Bracing

Type (a) metal angle braces were used for the external and internal wall bracing. The capacity of the current bracing is only 0.8kN/m. The location and the type of bracing should be selected with AS 1684.2 or by structural engineer. Current bracing should be assessed by a structural engineer and an adequacy certificate should be provided to the project client.

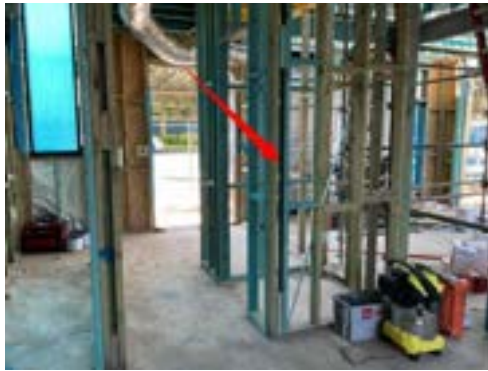
Junction Blocks

All intersecting walls must be fixed at their junction with blocks fixed to each wall with 2/75 mm nails. Blocks must be installed at 900 mm max. centres. Refer to AS 1684.2-2010 Clause 6.2.1.3.

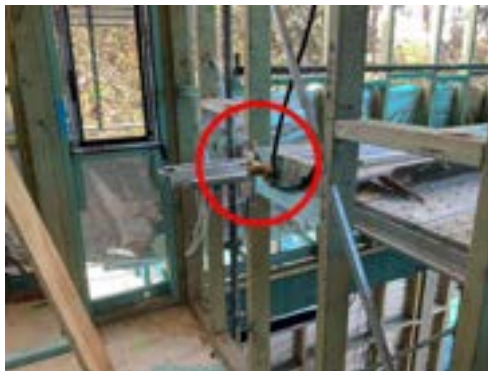
Studs

The maximum size and spacing of cuts, holes, notches, and similar section-reductions, in studs and plates, must be in accordance with Figure 6.4 and Table 6.1. Holes in studs and plates must be located within the middle half of the depth and breadth of the member, respectively. Refer to AS 1684.2 Clause 6.2.1.4.

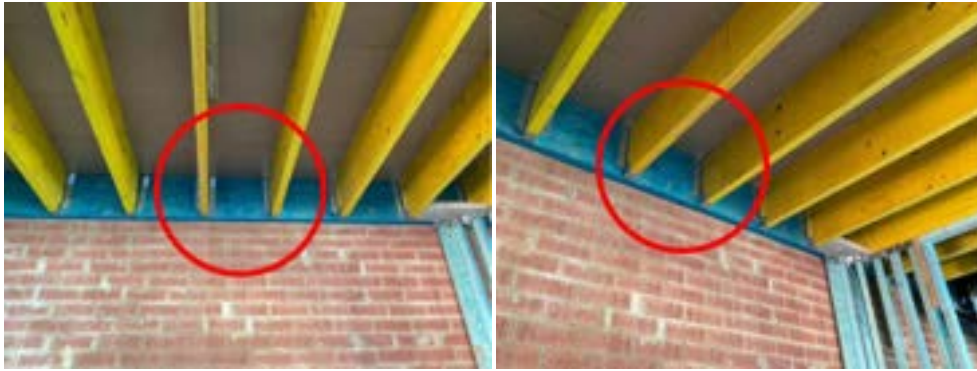
Fixing Nail

It appears to be clout nails were used to the joist hanger connection. All nails should be corrosion protected flat-head connector nails. Clout nails must not be used for this purpose.

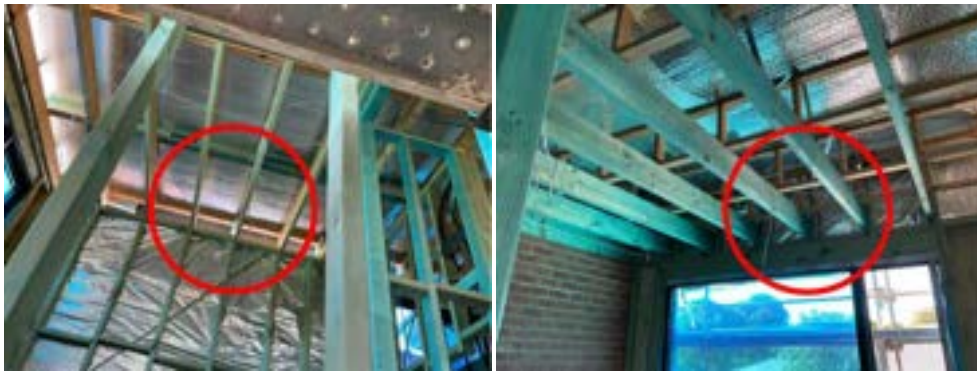
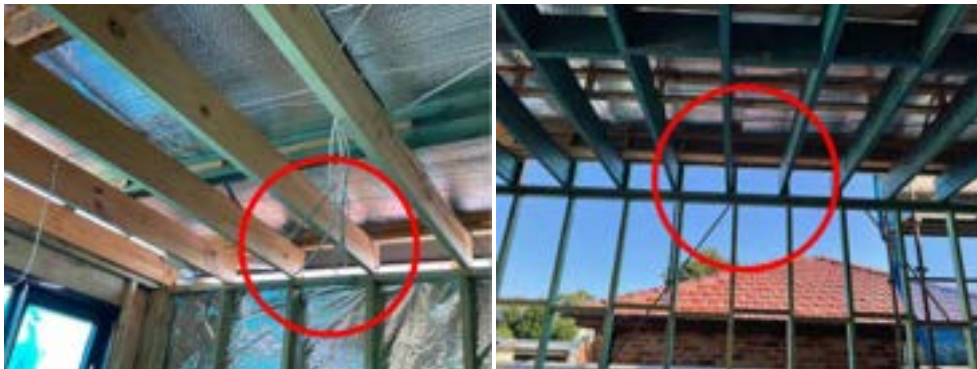
End Blocking Deep Joists

At the end deep joists and rafters, a continuous trimming joists or solid blocking should be provide at not more than 1.8m.

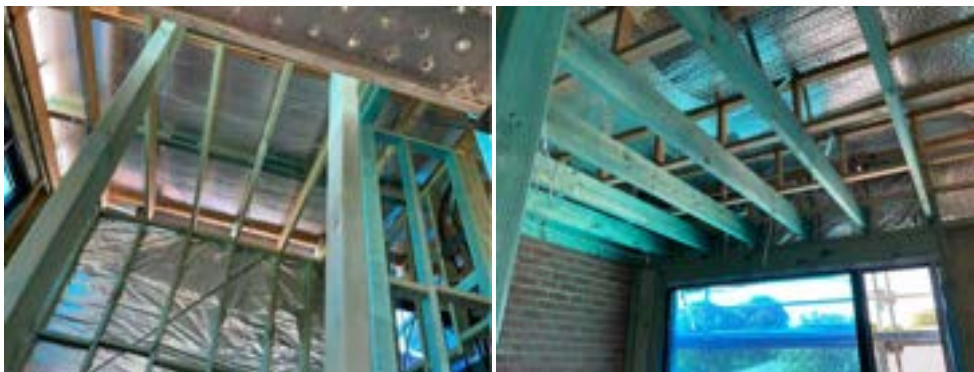
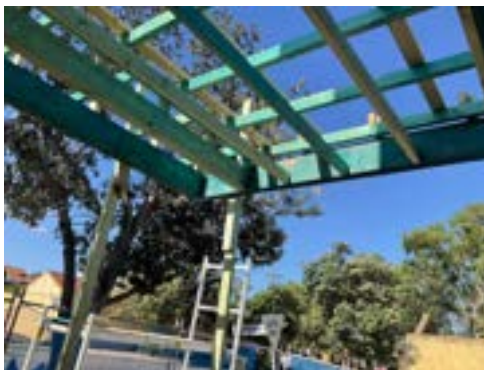
Deep Joists

Deep joists and rafters spanning 3m to 4.2m blocking must be provided in the mid-span according to the structural engineer's plan.

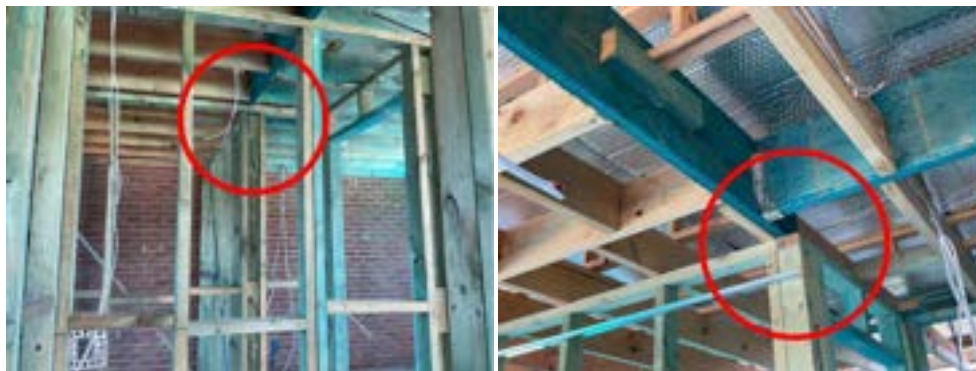
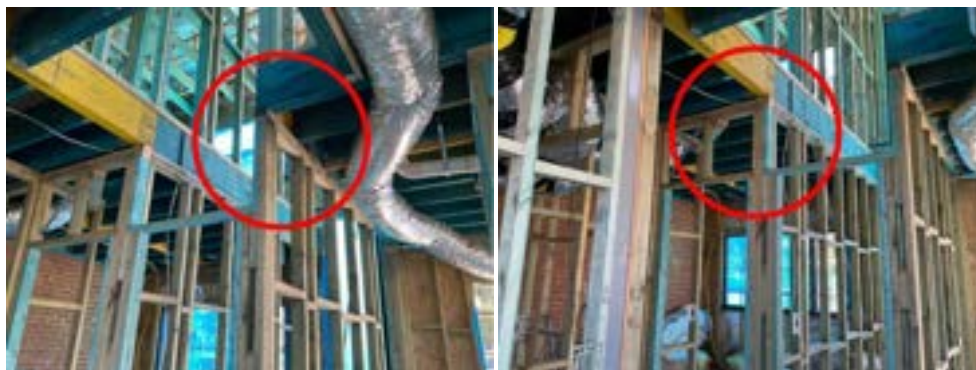
Timber Beam Support

The timber beam supports are not comply as per the engineer's plan. All timber beams must be supported on triple studs with double noggings or 90x90 hardwood post.

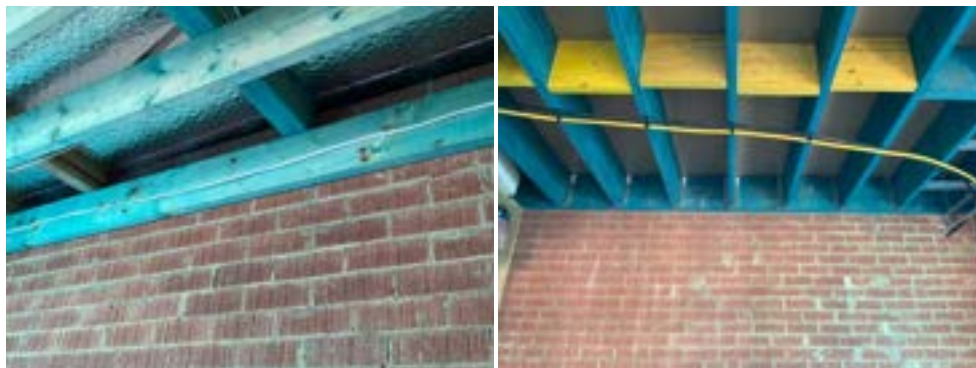
Timber Beam Connection

The timber beam to brick wall is not comply with the engineer's plan. M16 bolts must be used for timber beam (NB1) connection to the brick wall but M12 bolts were used for the connection.
