!! !"#\$%&'()*+,-./:;<=>?@A B C D E F G H I J K L M N O P Q R S T U V W X Y Z [\] ^ _ ` { | } ~ ¡ ¢ £ ¤ ¥ ¦ § ¨ © ª « ¬ ® ¯ ° ± ² ³ ´ µ ¶ · ¸ ¹ º » ¼ ½ ¾ ¿ Fram & (Stage Report

Besafe Group Pty Ltd

Progress Inspection Report

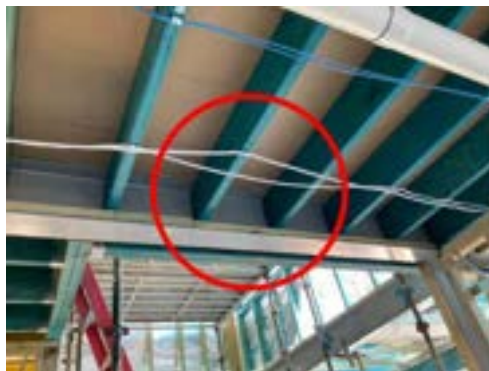
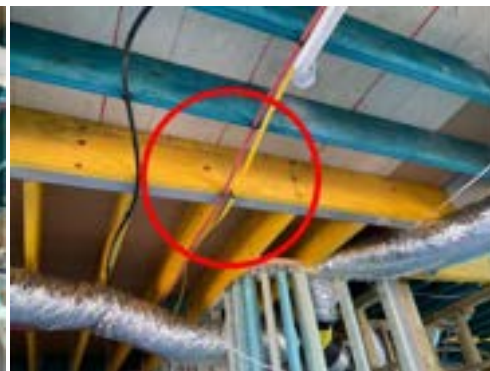
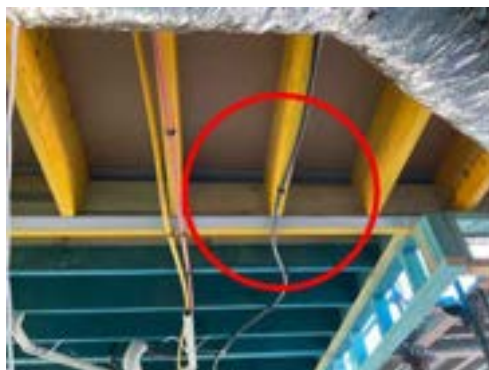
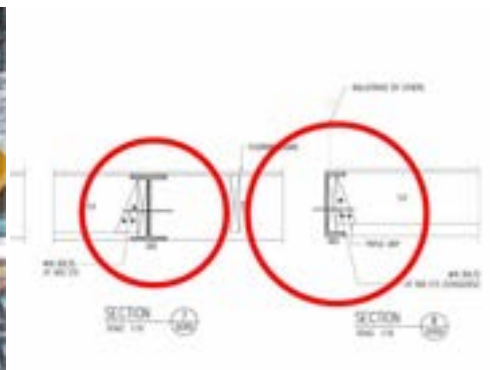
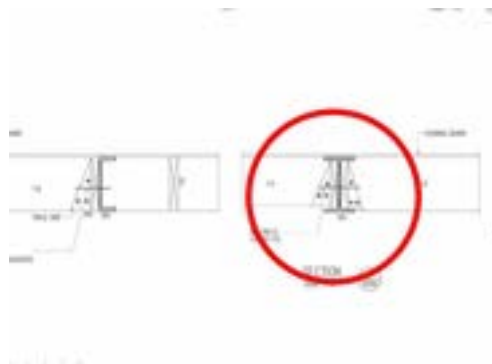
The timber beam to brick wall is not comply with the engineer's plan. M16 bolts must be used for timber beam (NB1) connection to the brick wall but M12 bolts were used for the connection.
